HEBRON

ST CUTHBERT'S CHURCH AN ARCHAEOLOGICAL ASSESSMENT JUNE 2020

PETER F RYDER

HISTORIC BUILDINGS CONSULTANT

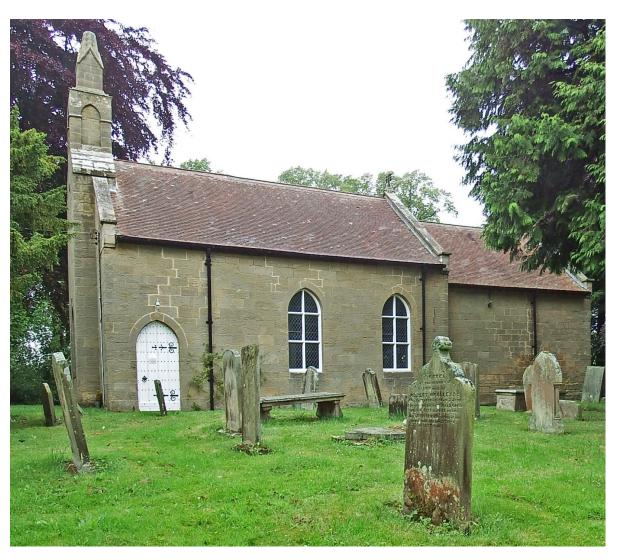
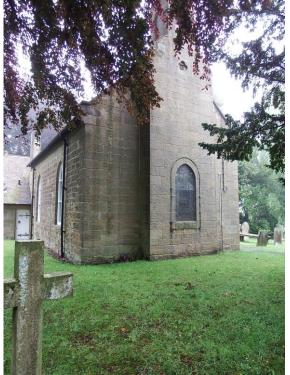
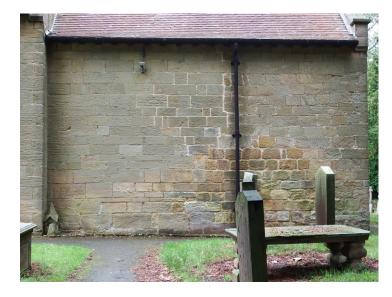
The church from the south-west
(left) North-west view
(right) Chancel from south

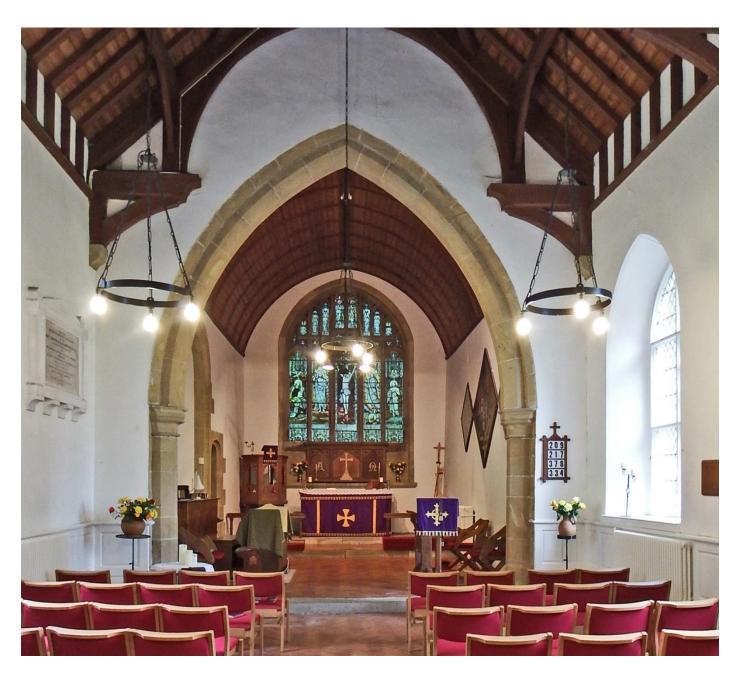
Interior looking east
