THE PARISH CHURCH OF ST MARY, MORPETH  
ARCHAEOLOGICAL WATCHING BRIEF  
WINTER 2012/2013

**St Mary's Church, Morpeth. Archaeological Watching Brief, Winter 2012/2013**

**NC ref. CM 16/19; 15569. NGR NZ 1971 8509. PFR 877. Oasis ref. peterfry1-144515**

### **An Archaeological Watching Brief, Winter 2012/2013**

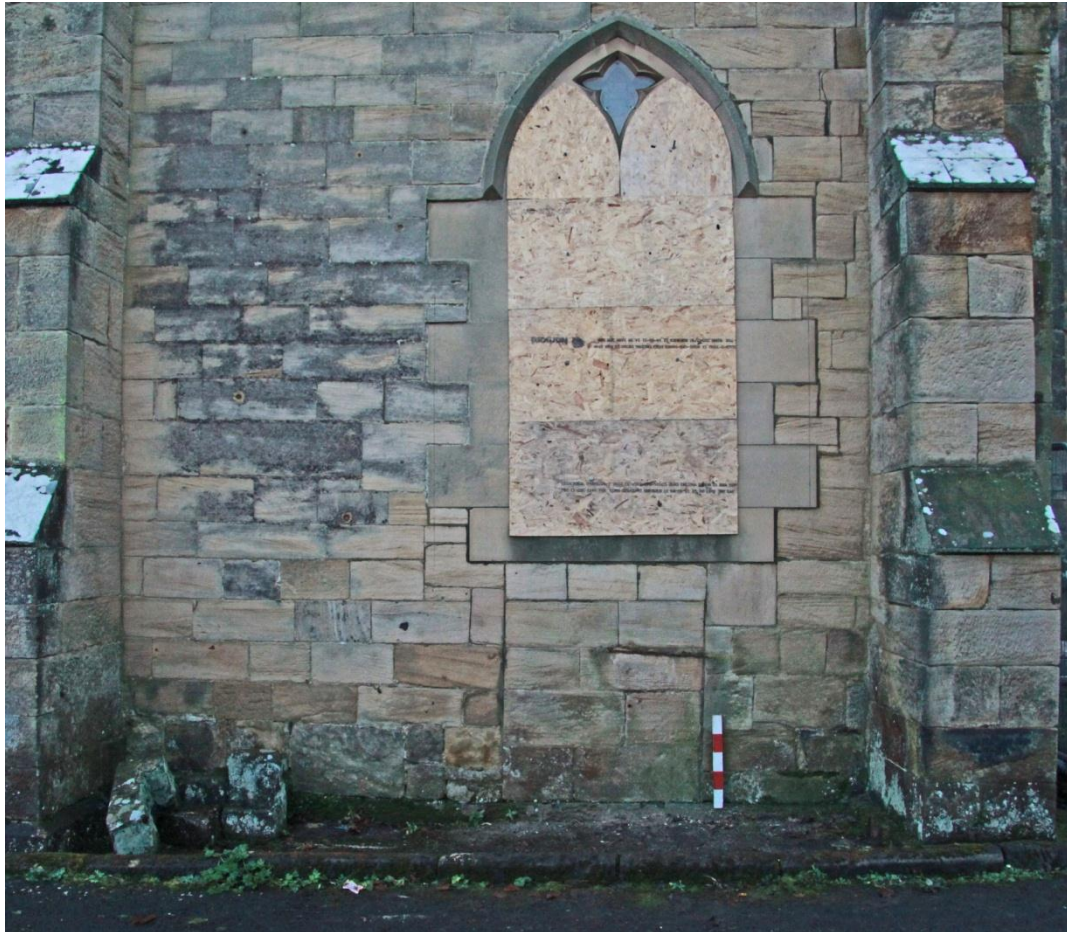
*The exterior of the north wall, before works*

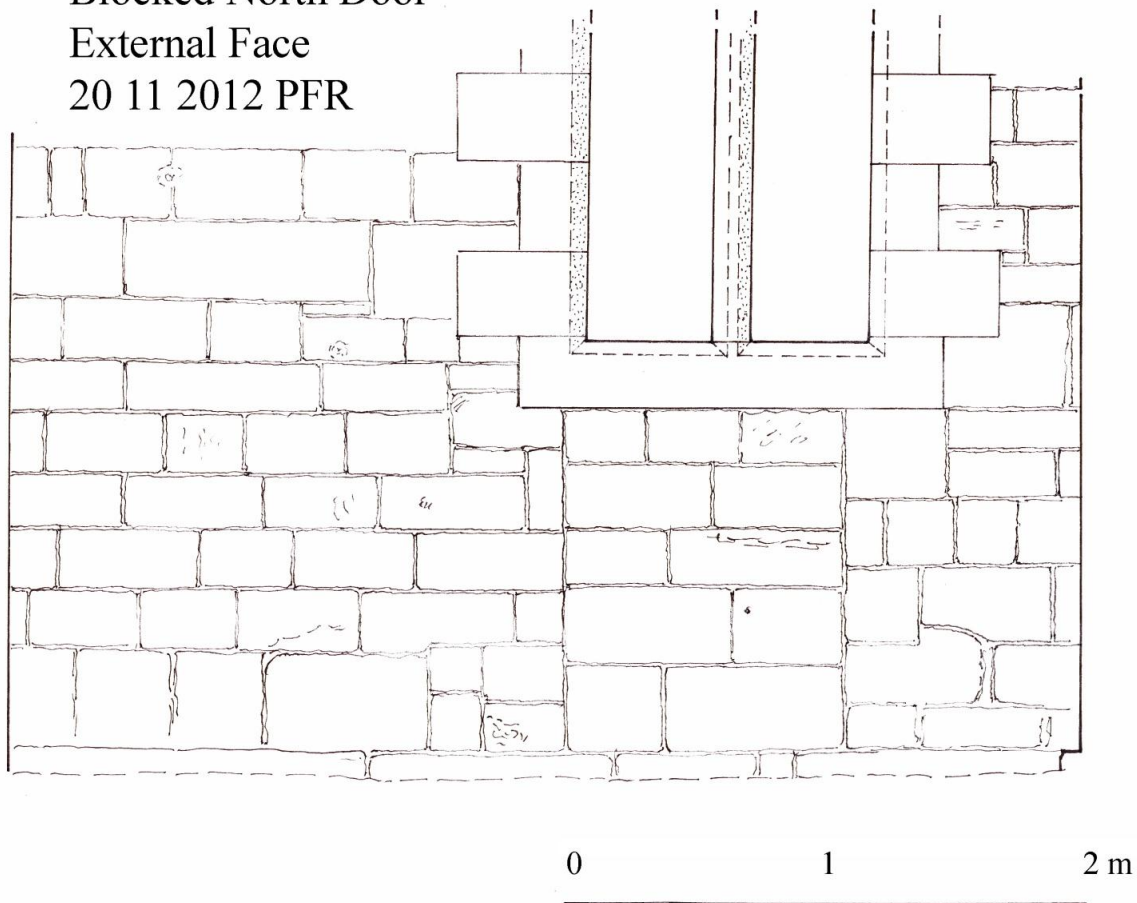
Illus.2 External Elevation of North Doorway before works

3.3 On the external face of the wall the jambs of the doorway formed straight joints, 1.10 m apart, rising from the top of the chamfered plinth to the sill of the 1953 window 1.35 m above. Most but not all of the jamb stones seemed to course in with the wall fabric, of which only a few stones, mostly in the lowest course, look 'old'. As pointed out in the 2003 assessment, the manner in which the walling stones stood 'proud' of the ashlar jambs of the window dressings – which were presumably set vertical – rather suggests they are old work that has been re-tooled rather than a full 19<sup>th</sup>-century rebuild.

MORPETH, ST MARY'S CHURCH  
Blocked North Door  
External Face  
20 11 2012 PFR

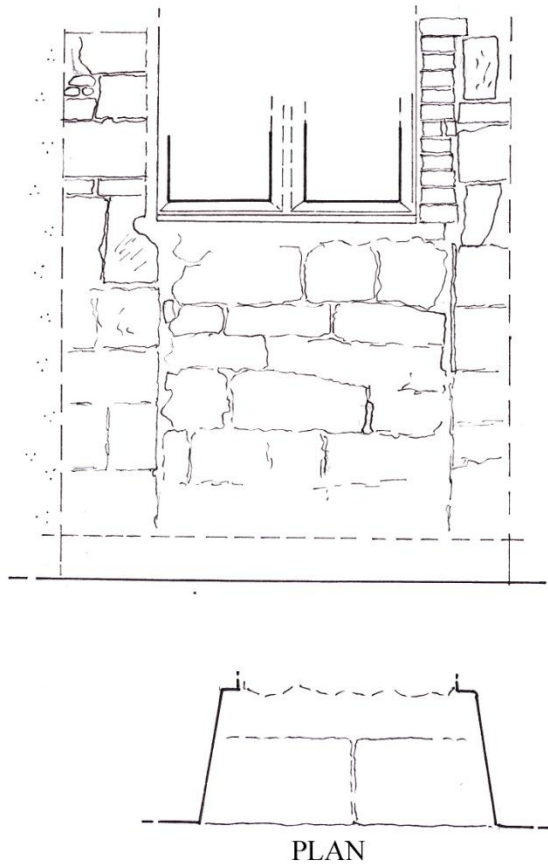
Illus.3 Internal Elevations of North Doorway

3.4 Stripping the plaster from the internal face of the wall revealed the jambs of a splayed opening 1.32 m wide, coursed in with the adjacent walling and apparently coeval with the wall, ie of 14<sup>th</sup> century date. The opening was blocked with roughly-squared stone laid in irregular courses, with no clue as to its date.

MORPETH, ST MARY'S CHURCH  
Blocked North Door  
Internal Face 20 11 2012

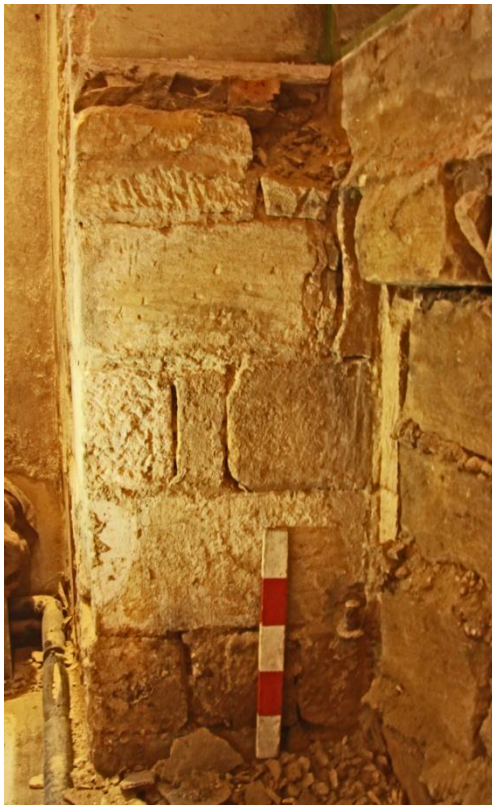
Illus.4 Internal West Jamb of North Doorway (note pintle)

3.5 When the blocking stonework was revealed, the former doorway was revealed to have jambs with an internal rebate and externally a narrow chamfer, which had been mutilated by a small external rebate being cut into it; within the chamfer the doorway had been exactly 1.00 m wide. There was no evidence of any drawbar tunnel (such as the south door has) but the west jamb had one old pintle for the former door (see appendix 1), led into position, and the east jamb a mutilated plate with a circular hole for a bolt, which unfortunately was misplaced by the contractors before it could be recorded in detail.

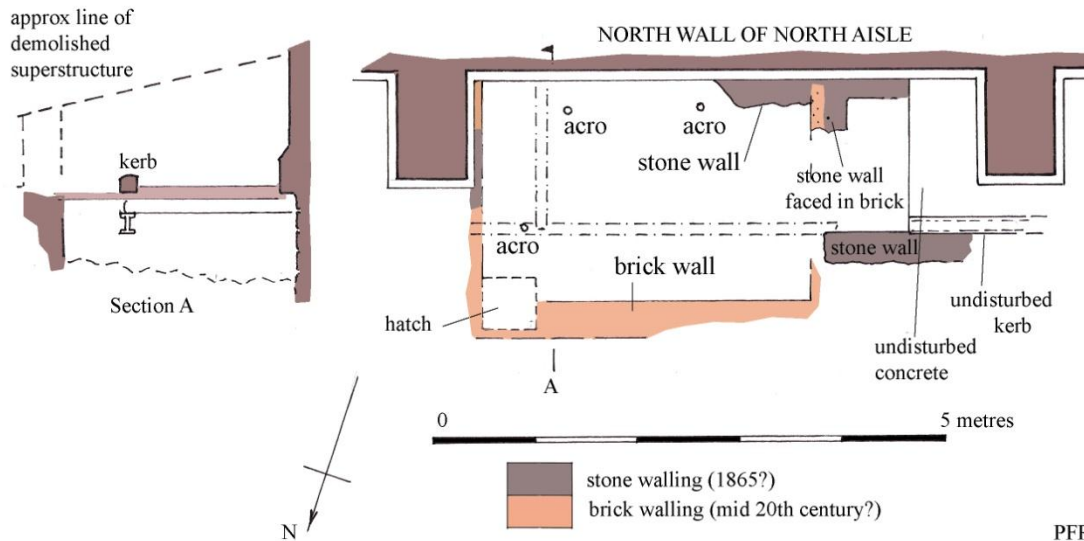
Illus vi. Plan of Boiler Room

5.1 A service trench was opened from the new north door running westwards along the line of the churchyard path, to (and beyond) the lych gate. As expected, this trench entirely lay within the line of previous service trenches, and only disturbed ground was encountered. Immediately outside the new doorway the 1865 pre-restoration plan shows a buttress, but no evidence of this survived. The only structural remains seen were those of a boiler room set between the third and fourth buttresses (from the west) of the aisle. In its final stage this had been a semi-subterranean structure 3.2 by 2.2 m internally, rather shorter than the 'furnace' showing on Wilson's 1870 plan<sup>2</sup> (p.2) which extended 4.9 m from buttress to buttress, and was entered by a flight of steps at the north-east corner. This original structure was of stone, but at some time it was remodelled (and shortened at its west end) in brick. In the mid/late 20<sup>th</sup> century the boiler room had been abandoned and its above-ground structure demolished (it would; appear to have had a pent roof, of which some evidences remained on the aisle wall c 1m above the ground). It was partly infilled with debris (including two fitting pieces of an 18<sup>th</sup>-century monument, see appendix) and a concrete pad placed over it, supported on girders, with access to the partially-infilled space being by a hatch at the north-east corner; the pad later failed and additional support in the form of several acro props had to be installed.

At the south end of the east wall of the boiler room was a bricked-up opening which had clearly carried a flue which rose inside the adjacent buttress to a vent at the top.

Remains of Boiler Room: Sketch Plan and Section, January 2013 P F Ryder

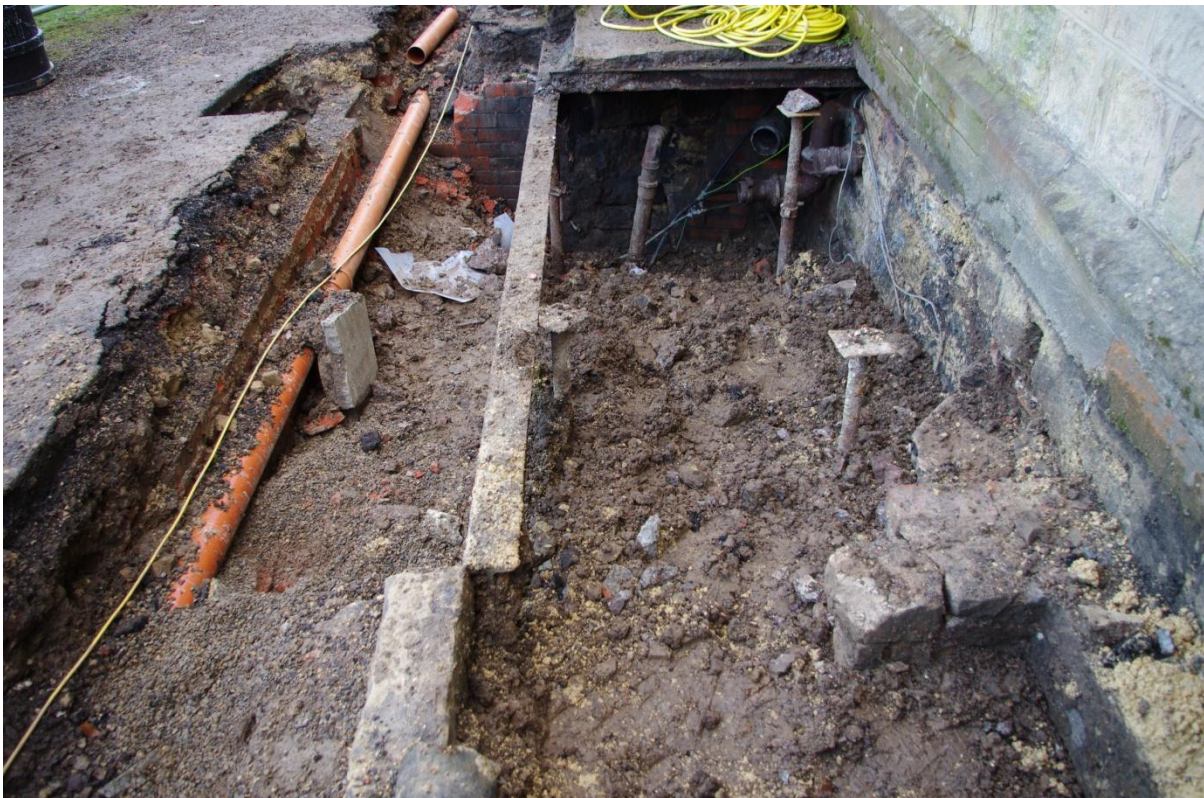
Illus vii. Remains of Boiler Room looking east

Concrete slab over boiler house now largely removed; this is partially infilled with debris, quite a lot of pipework still in position – to be filled in completely. Sketched and photographed. Seemed to be two phases of work, large squared stone and (mid C20?) brick. Two pieces of headstone, with well carved later C18 inscription, retrieved from debris, taken by PFR to be cleaned and photographed.

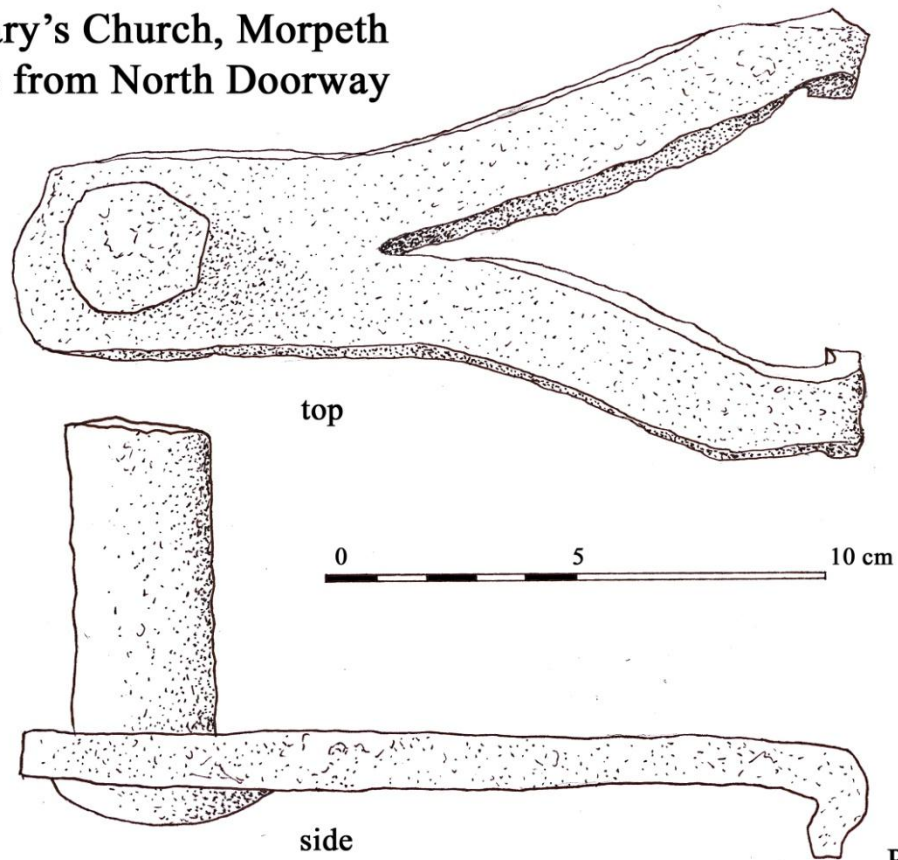
Illus ix. Drawing of Pintle from North Doorway

8.1 This was presumably the lower of a pair of pintles fixed to the interior of the rebate of the west jamb of the doorway. It consists of a plate originally 170 by 40 mm and c 10 mm thick which has been split and splayed into a Y-form, with the two ends being bent and twisted down to form tangs, and an upright shaft 60 mm high and 28 mm across fitted through it, and hammered to a shallow dome-like form on the lower face. The exposed sections of shaft and plate were coated with an oxidised layer; the tanged ends of the plate, which had been coated in lead, were still clean grey iron.

8.2 From the manner in which the pintle was fixed into the wall it would seem highly likely to be contemporary with the wall fabric, that is, of 14<sup>th</sup> century date.

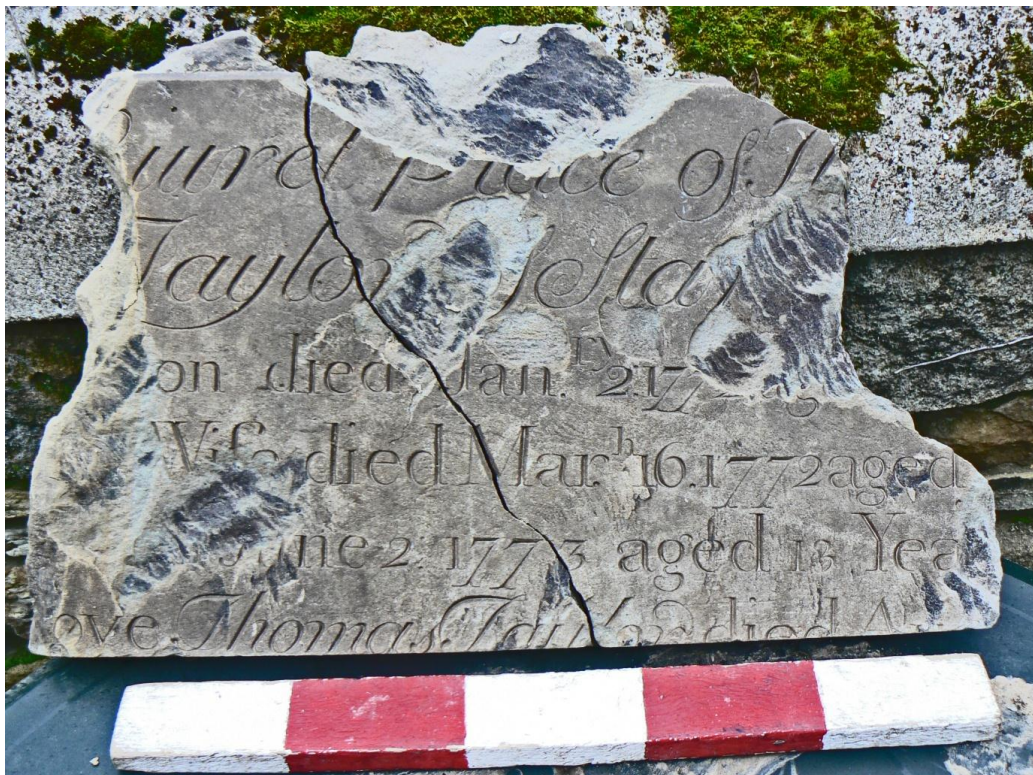
Illus x. Monument from fill of Boiler Room

9.1 In the loose infill of the external boiler room, two matching fragments of an 18<sup>th</sup> century monument were found, together making up a piece c 600 by 400 mm and 40 mm thick of fine-grained greenish sandstone. The lettering is of excellent quality (despite the strange mis-spelling of 'Burial' in the first line).

Nowhere does the original edge of the stone survive; the top and sides are ragged breaks, and the base has been sawn on a slightly oblique line.

9.2. It is no clear what the original form of the monument was; it would seem more likely to be part of a table tomb than a headstone. 'Stan' is probably Stannington, the next parish to the south.
