THE CHURCH OF ST MICHAEL, FELTON NORTHUMBERLAND

AN ARCHAEOLOGICAL ASSESSMENT APRIL 2008

PETER F RYDER

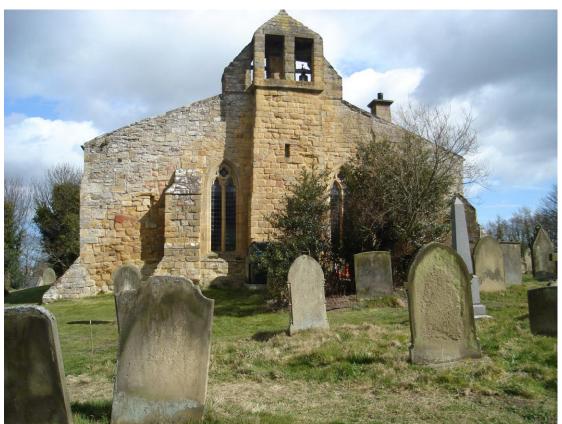
In the centre of the west end of the **Nave** (above) is a broad buttress-like projection carrying the bell-cote, but which also contains a newel stair, lit by a vertical pair of small upright loops; above these is oversailing chamfered course below the bell-cote/belfry itself, which has a pair of square-headed openings under a rough pyramidal cap, single square-headed opening to north and south, and another pair of openings with semi-shouldered heads on the east; it is within these that the two bells are now hung. The oversailing course is returned along the gable, which is carried up behind the bellcote to a common apex; it is also present on the east face of the bellcote, above the nave roof. Between the bellcote and the buttresses on the line of the arcades are panels of walls with an old chamfered plinth below an 1870 window of two trefoiled lights with a quatrefoil in the spandrel.

The buttress on the line of the south arcade is a substantial stepped one, once one of a pair, the second of which is now incorporated in the west end of the south aisle. In

contrast that on the line of the north arcade has clearly been a heavy clasping buttress, with sloping off-sets, at the north-west angle of the original aisleless nave.

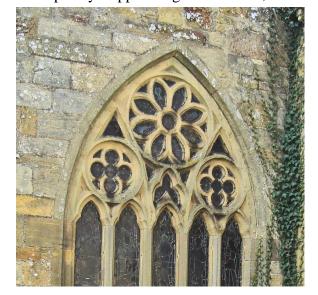
chamfered plinth is continued around the buttress and along the east wall of the aisle. The east window of the aisle (right) is a remarkable one. Whilst its jambs, sill and mullions are all of 19th-century parallel-tooled ashlar, its head is a remarkable monolithic one of five narrow trefoiled lights with geometrical tracery above, comprising a big central circle with eight petals around an open roundel, above a pair of smaller circles with quatrefoils, flanking a smaller spheric triangle, all enclosed by a two-centred arch with a hollow-chamfered surround.

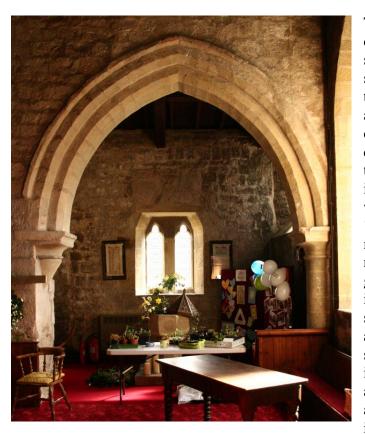
The south arcade of the nave is of four irregular bays, with a short length of wall on either side of the second arch from the west. The westernmost arch (left) is a two-centred one of two chamfered orders with a chamfered hood towards nave that ends well above the imposts. The semicircular western respond has a moulded 'holdwater' base and a simple moulded capital round at the neck square at abacus, and a grooved and chamfered impost. The eastern has a similar capital but is carried by a conical corbel sprung from square block of walling, which in the south face (towards the aisle) has an offset of c 0.20 m at c 1.5 m above the floor. The individual voussoirs all seem

to have too sharp a curve for the present form of the arch, suggesting that they have been re-used from a smaller opening.

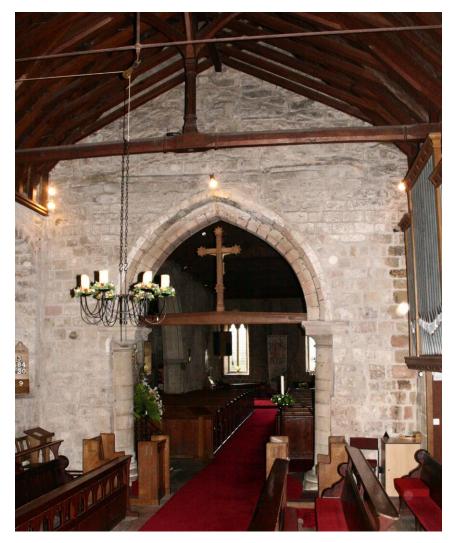
The arch into the **Chancel** is of segmental-pointed form, now somewhat distorted, and is of two chamfered orders with a damaged hood, chamfered on lower angle, only towards the nave, now retaining a fragment of a terminal c 0.3 m above the south respond but broken away at a higher level on the north. The responds are semicircular shafts with bases that have bold mouldings of 'holdwater' type; the capitals, which may have been re-cut, have grooved and hollow-chamfered square abaci but are round at the neck, with a ring below. Towards the chancel there is evidence of patches of disturbed or replaced fabric adjacent to both jambs of the arch; this seems more likely to relate to patching or repair rather than being a survival of a wall face pre-dating the present chancel; the remainder of the wall is of good squared masonry, with a horizontal set-back just above the crown of the arch, and above that the clear line of the two lower-pitched roofs that preceded the present Victorian one.

The chancel looking west; Note patched masonry in jambs of arch, and evidence of two earlier roof-lines

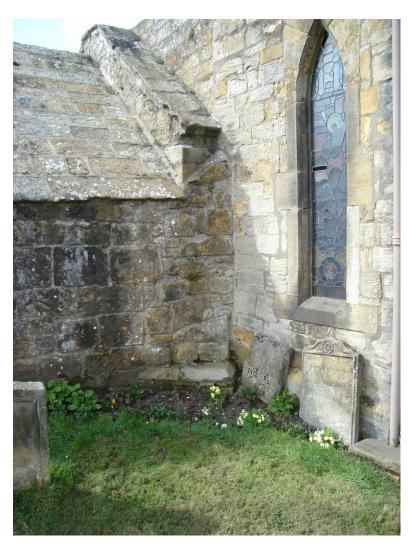
The east side of the south porch, showing the gabled Front of the phase II porch behind its phase V successor. In the angle between porch and aisle wall is the base of the diagonal south-eastern buttress of the phase II porch. On the right is a mid-19th century lancet window in the phase IV aisle wall.
