# The Church of St Cuthbert

## Corsenside

An Archaeological Assessment

January 2012

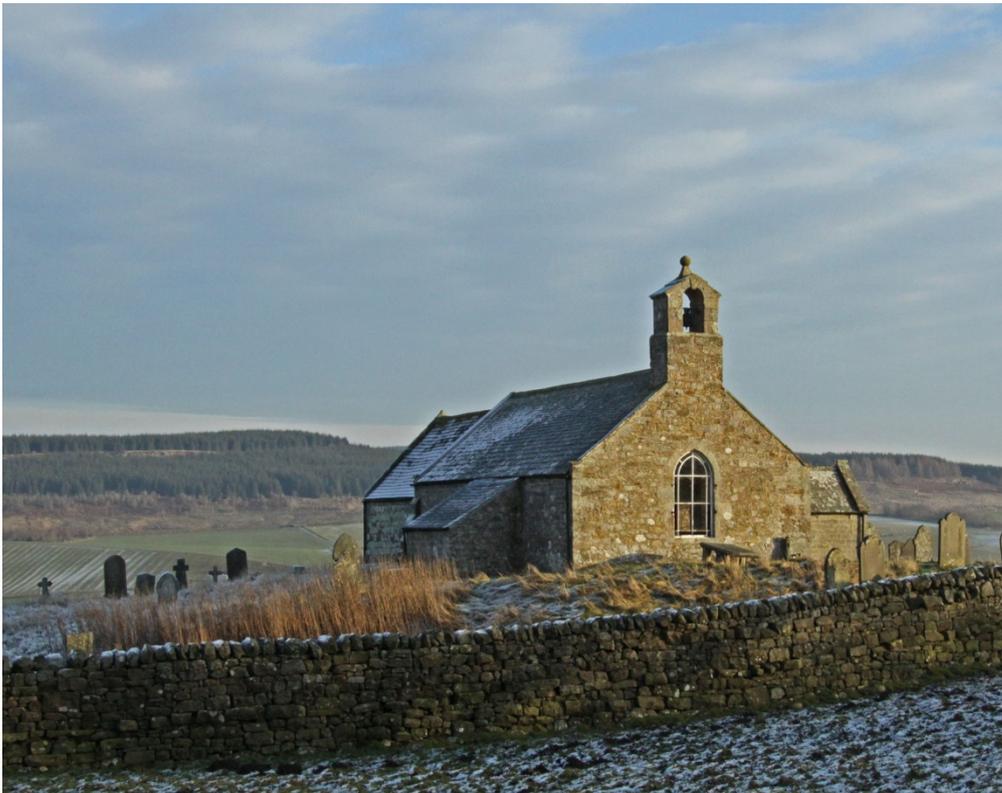
*The church seen from the north-west*

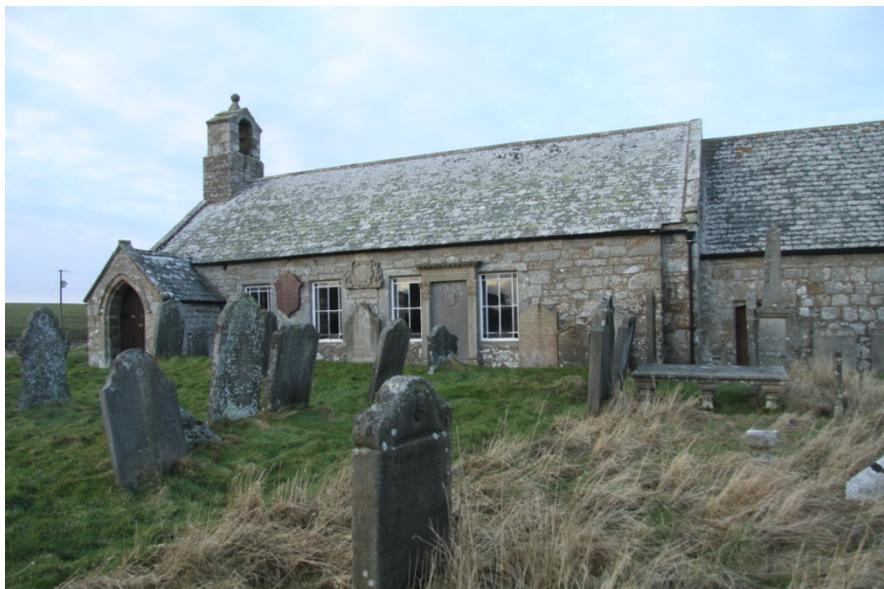
The porch is set at the west end of the south wall of the nave, and is built of coursed pecked stone with ashlar dressings; its outer opening has a two-centred arch with a continuous hollow chamfer, and a hollow-chamfered hood with turned-back ends. East of the porch are four identical square-headed windows (below), similar to the west window in having very

narrow chamfers to their surrounds, and margined glazing. A number of monuments have been set on or against the wall; between the easternmost two windows is a large tablet to a Matthew Reed, d.1755, flanked by fluted pilasters carrying a dentil

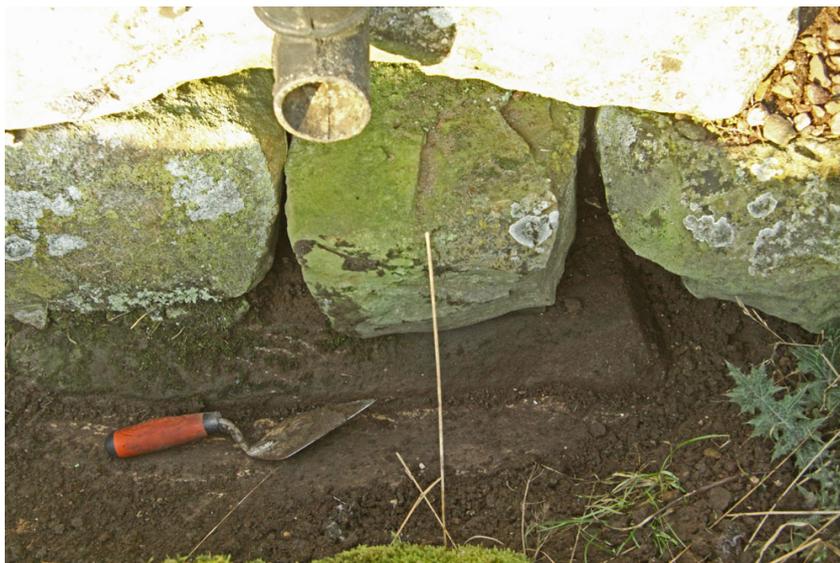
the external face of the present east wall, and then returns north (right) At each end of the east wall there is a projecting footing at the present ground level, which is c 0.50 m above the top of the plinth exposed in the drainage trench<sup>1</sup>. In the centre of the east wall is

a three-light window with simple intersecting tracery in tooled ashlar that is clearly of the later 19<sup>th</sup> century. The gable above has a raised coping of triangular blocks, of a form familiar in 17<sup>th</sup>/18<sup>th</sup> century vernacular buildings in the area. The north wall, like that of the nave, is devoid of any architectural features

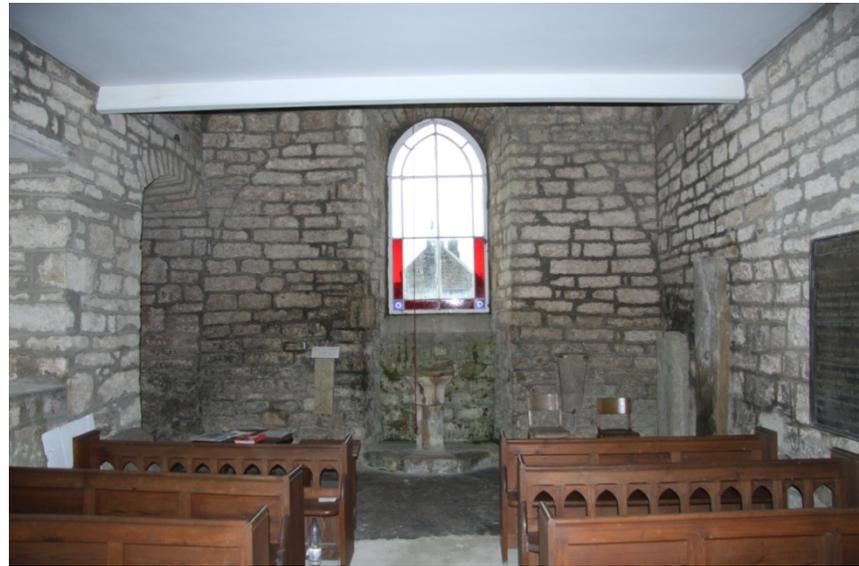
The internal walls of the church are all now bare of plaster; the fabric is much more clearly visible inside than out. The north wall of the nave is of especial interest; there are courses of large roughly-squared blocks to a height of c 2 m, than above that thinner and better-coursed stone. Looking at the wall face in profile, there is a slight inward curve just below the junction between the two fabric types, above which the wall face is vertical. Turning to the west gable end (where the west window has a segmental rear arch, and an internal recess carried down to floor level) this break in fabric type corresponds to the point at which what at first sight appears to be an early gable line meets the side walls. This line, formed by a clear break in coursing) is in fact slightly curved. Has this in fact been a gable-line, one would have expected it to be visible in the external face of the wall (despite the heavy

pointing) but it is not. The implication, confirmed by the break-in-profile of the internal face of the north wall, is that we are looking at the line of a removed tunnel-vault (below) . Corresponding evidence may exist on the east wall of the nave (and be hidden by the two large Commandments tablets) although it may well be that this wall pre-dates the vault, which might simply have butted up against it.

One of the most interesting features of the nave is that there is clear evidence for its being vaulted, which rather surprisingly does not seem to have been noted previously<sup>3</sup>. This is almost a defensible, or at last a fire-proofing move, related to the troubled later medieval and early post-medieval period. Quite a number of Northumberland churches have defensible features, and two in parishes adjacent to Corsenside, Bellingham and Elsdon, have vaults – at Bellingham, over the nave and south transept, and at Elsdon over the aisles; further north Kirknewton has vaults over chancel and south transept. The vaults at Elsdon may be part of a late 16<sup>th</sup> century reconstruction, and at Bellingham of early 17<sup>th</sup> century date. At Corsenside the double-stepped south-east angle of the nave seems likely to indicate an external thickening of the wall, presumably made to take the weight of an inserted vault. Was the north wall of the nave similarly thickened? The discontinuity between the 12<sup>th</sup>-century fabric of the east wall and the quite different wall fabric of the north suggests a rebuilding rather than a simple thickening on this side. On the internal face the more thinly-coursed upper masonry clearly post-dates the vault, but there seems a similar change in fabric externally, suggesting that the upper part of the wall may have been completely rebuilt rather than just refaced on the inside. The blocked opening visible internally near the west end of the wall is a real puzzle. The only interpretation would seem to be that the wall has been considerably reduced in height; so does this high-level opening relate to an early nave prior to the insertion of the vault, or, more intriguingly, to a high-level chamber set above the vault? This would suggest that the nave was converted into a

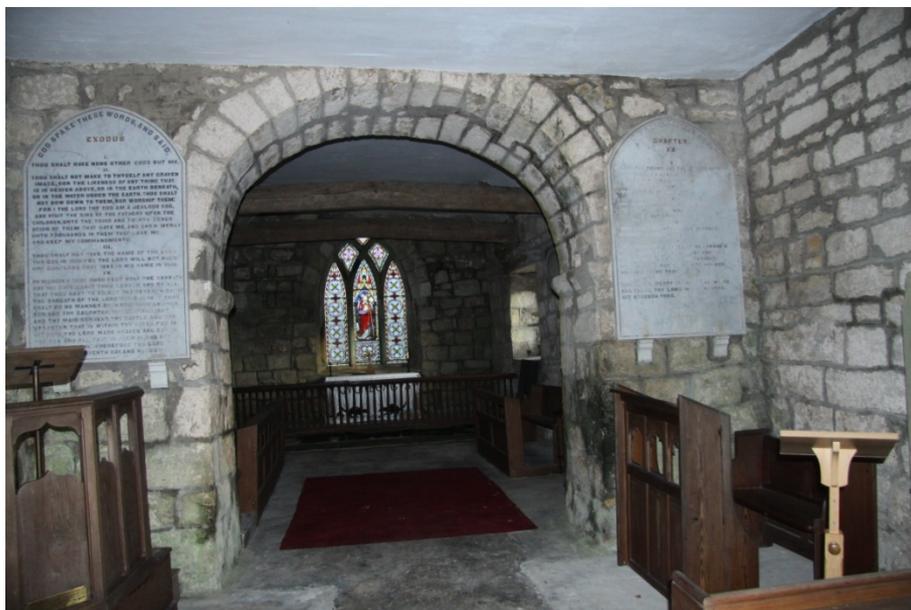
The east wall of the nave<sup>2</sup> contains the earliest feature in the building, the 12<sup>th</sup>-century chancel arch. This is a plain arch, semicircular but now a little distorted, of one square order, springing from an impost band, square above and chamfered below. The band is returned on the east face of the wall; any evidence of its return on the west face is now concealed by the Commandments tablets, but on this side there do seem to be fragments of a cut-back hoodmould. The wall on either side of the arch is of large quite square blocks, quite distinct from any other fabric in the church, and clearly of one build with the arch itself. Each of the

responds has a vertical pair of small square sockets, set centrally, one c 1.5 m above the floor and the other immediately above the impost. Above the ceiling the west face of the wall (only observed from a distance) is plastered, although there are possible traces of a central opening.

*The chancel arch from the west; note traces of cut-back hoodmould*

The chancel arch is clearly Norman, and of a very simple form; it has been ascribed a date as early as the late 11<sup>th</sup> century, but is probably more safely put into the 12<sup>th</sup>. How much else of the Norman church survives? The wall in which it is set seems contemporary with the

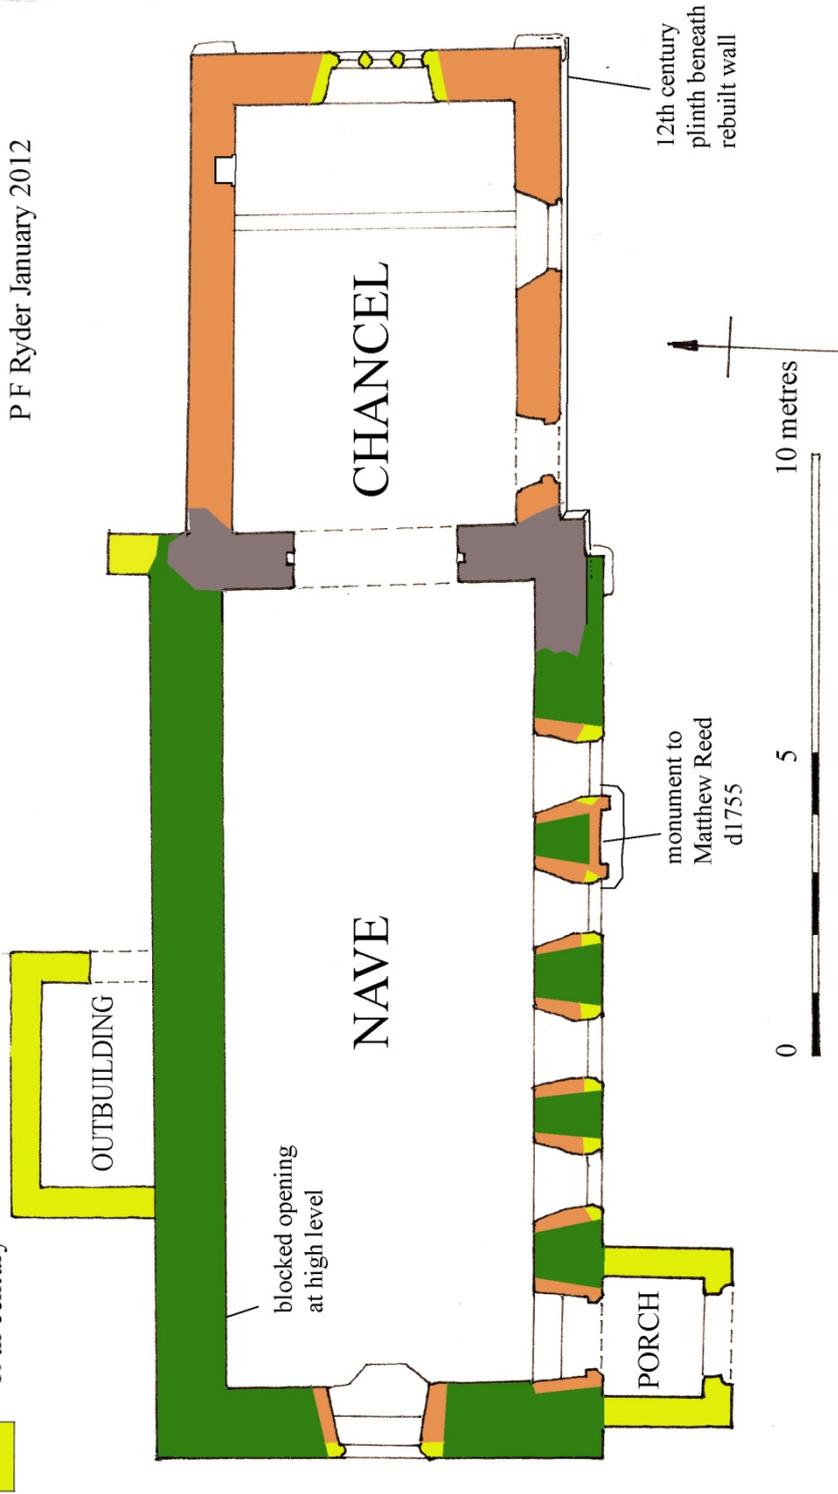
## Provisional Phased Ground Plan

Provisional Phasing

- 12th century
- Uncertain/later medieval  
1735?
- 19th century
