Bolton Chapel

An Archaeological Assessment

July 2013

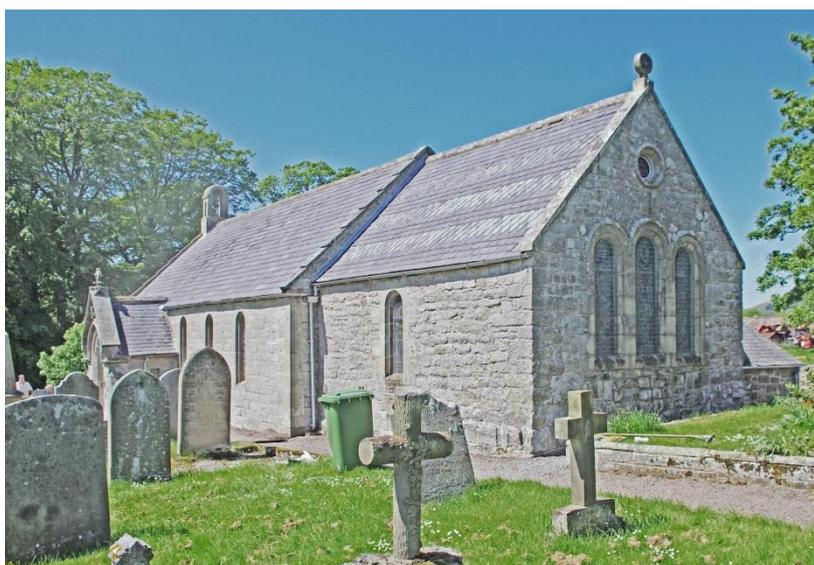
The church seen from the south-east

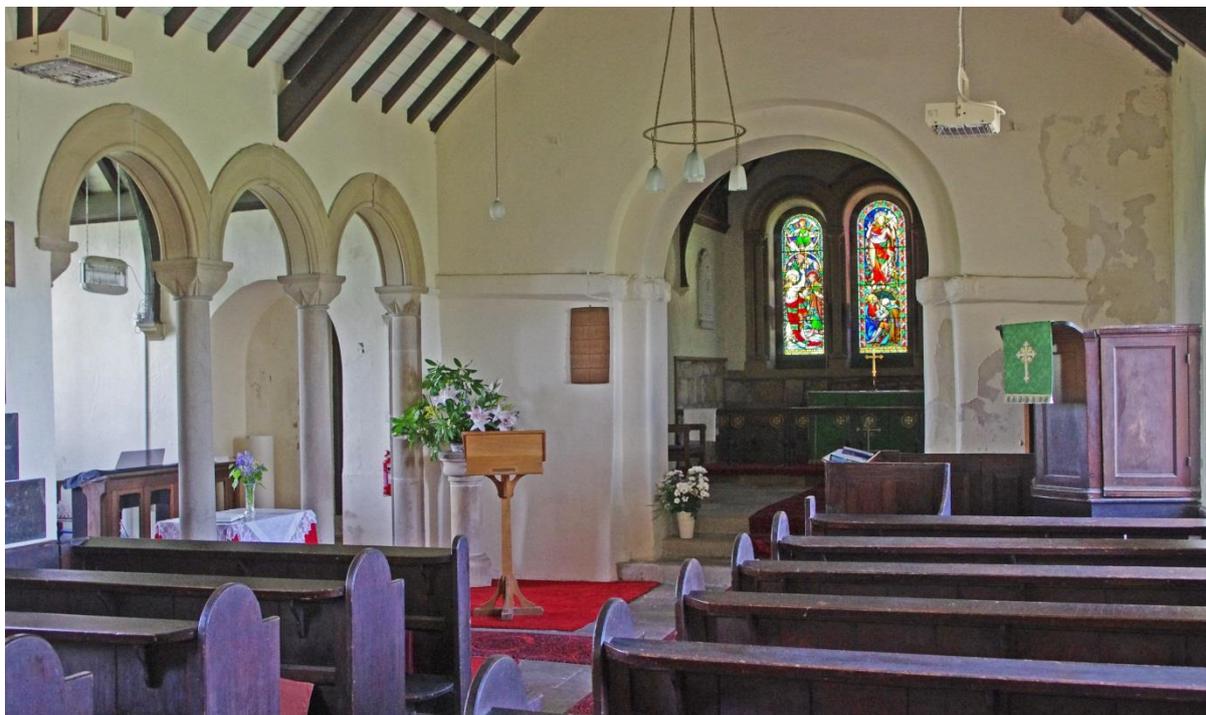
Interior looking north-east

The interior of the church is plastered, except for the lower walls of the sanctuary and the ashlar of the arcade to the transept and rear arches of the eastern triplet of the chancel. The windows, and south doorway, all have plaster beads to their rear arches; the north transept opens to the nave by an arcade of three narrow round-headed arches in an odd hybrid of Romanesque and Classical styles; the slender circular piers and semicircular responds have scalloped capitals, but the arches have architraves of classical section with a roll-moulding and a shallow step. The nave roof is of six bays, having collar-beam trusses with upper king-posts, with stop-chamfers to the collars and posts, and vertical bolts holding the post to the

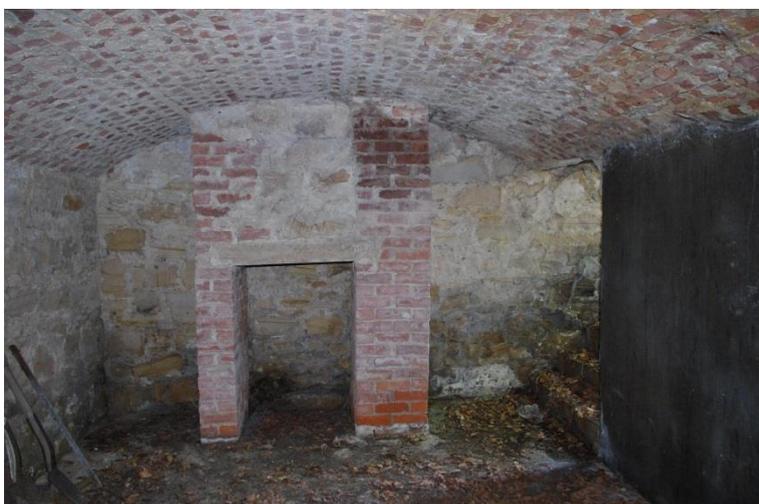
The vault beneath the vestry, now empty and perhaps never used, is reached by the stone stair entered from the external doorway on the north, and lit by a small window on the east. At its foot the stair opens directly into a chamber 4.90 by 3.06 metres, orientated east-west, with a brick barrel vault of shallow segmental section. The only feature is a projection in the centre of the west wall with what looks like a simple square-headed fireplace, but lacking any flue; it would appear to support a peculiar projection in the north-west corner of the vestry, which, plastered over, lacks any features to explain its function.

The vault, looking west, showing structure of uncertain function

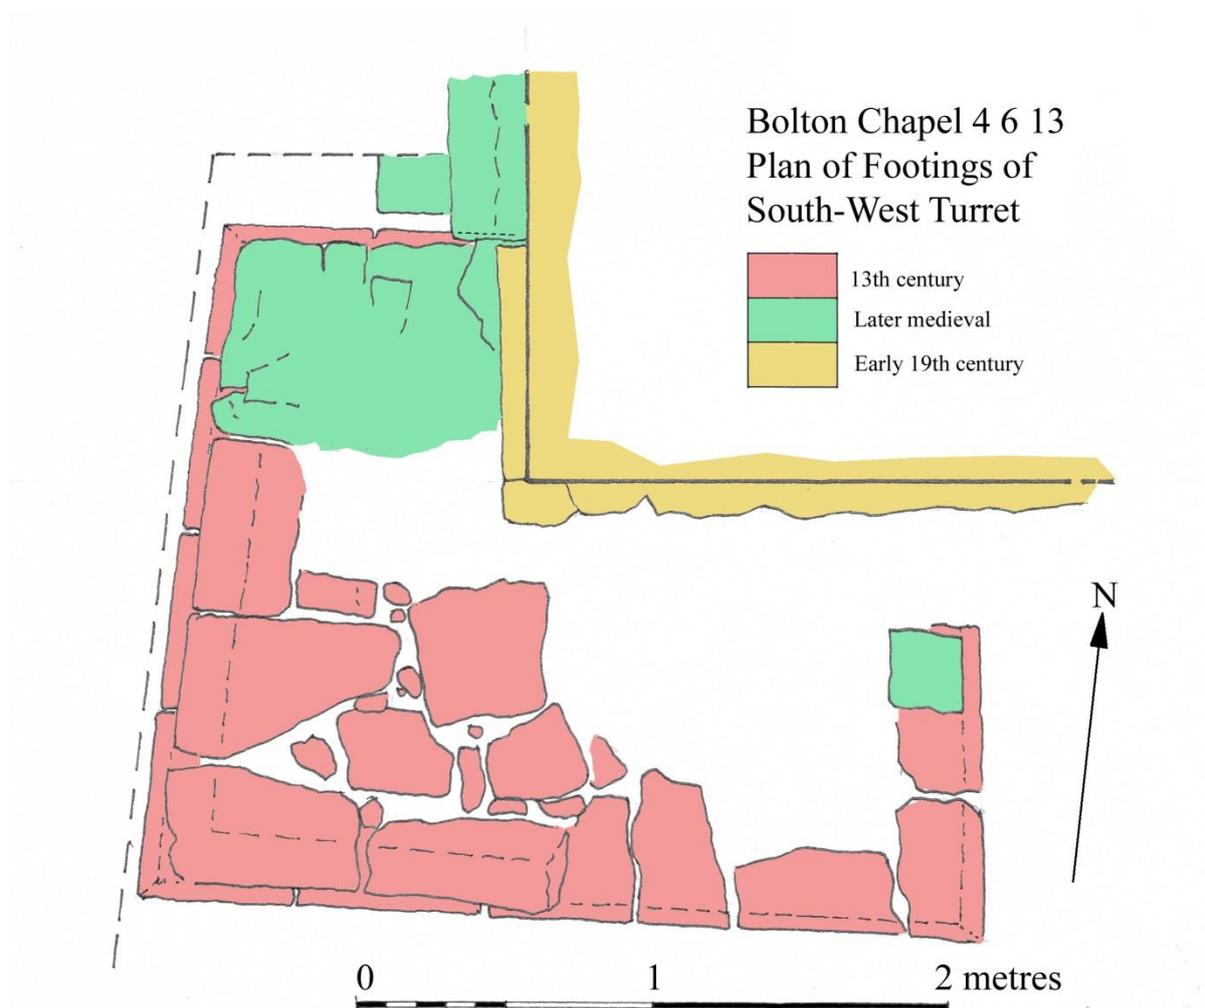
PFR 2013

During drainage works in June 2013 the footings of what appeared to be a small tower were uncovered at the south-west corner of the nave. The structure had a two part plinth, a small chamfered step with a taller one above, which was of general 13th century character; it measured 2.78 m east-west by 2.23 m north-south and projected 1.46 m beyond the south and

1.00 m beyond the west walls of the present nave. The plinth on its northern return in fact continues beneath the plinth of the west end of the later medieval nave, whilst that on its eastern return is cut short 0.50 m from the 19th century south wall. The lower member of the plinth remained intact except where cut away on the east; the upper member only remained around the south-west corner. On the south one of the large blocks of the upper member appeared to have been prised out of position, so that it overhung the lower. At the north-west corner, and in the centre of the east return, were blocks with faces that rose vertically above the lower chamber, interpreted as remains of later buttresses coeval with the rebuilding of the nave.

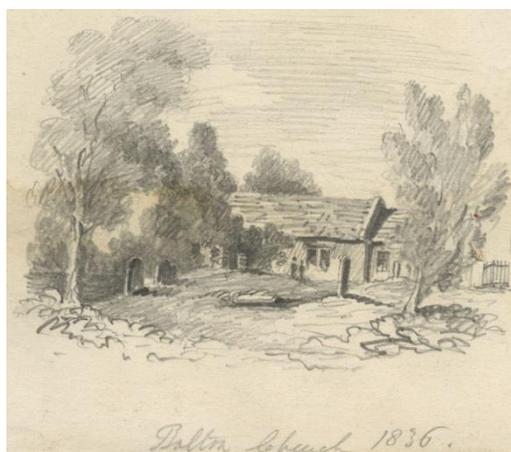
It would appear that by the early 19th century the chapel retained few medieval features other than its chancel arch. Wilson writes 'kept in repair by village masons and joiners, all the old features of the ancient church had been replaced with meaningless blanks, or renewed with those of a village cottage type, long before the days of the present generation'⁵. One illustration of the pre-restoration chapel has been traced, dated 1836⁶, showing the building seen from the south; both ends are hidden by trees, but there is a large square-headed two-light window under a label near the east end of the nave, and a plainer window at the west end of the chancel. The 1847 tithe map⁷ shows the building as a simple rectangle. The chapel is recorded as being 'rebuilt' in 1852⁸ which presumably relates to the rebuilding of the nave; structural evidence shows that the north transept pre-dates the nave rebuilding so that presumably dates to the late 1840s. The 1st edition Ordnance Survey 6":1 mile map shows the church with nave, transept and chancel; the south porch and vestry seem to have been added in 1869, when the chancel was 'restored' by Matthew Burrell, vicar of Chatton⁹. A small boiler room, now removed, was built in the external angle between transept and nave. There do not seem to have been any major structural changes since this date; panelling was removed from the interior in 1962¹⁰.

1836 drawing

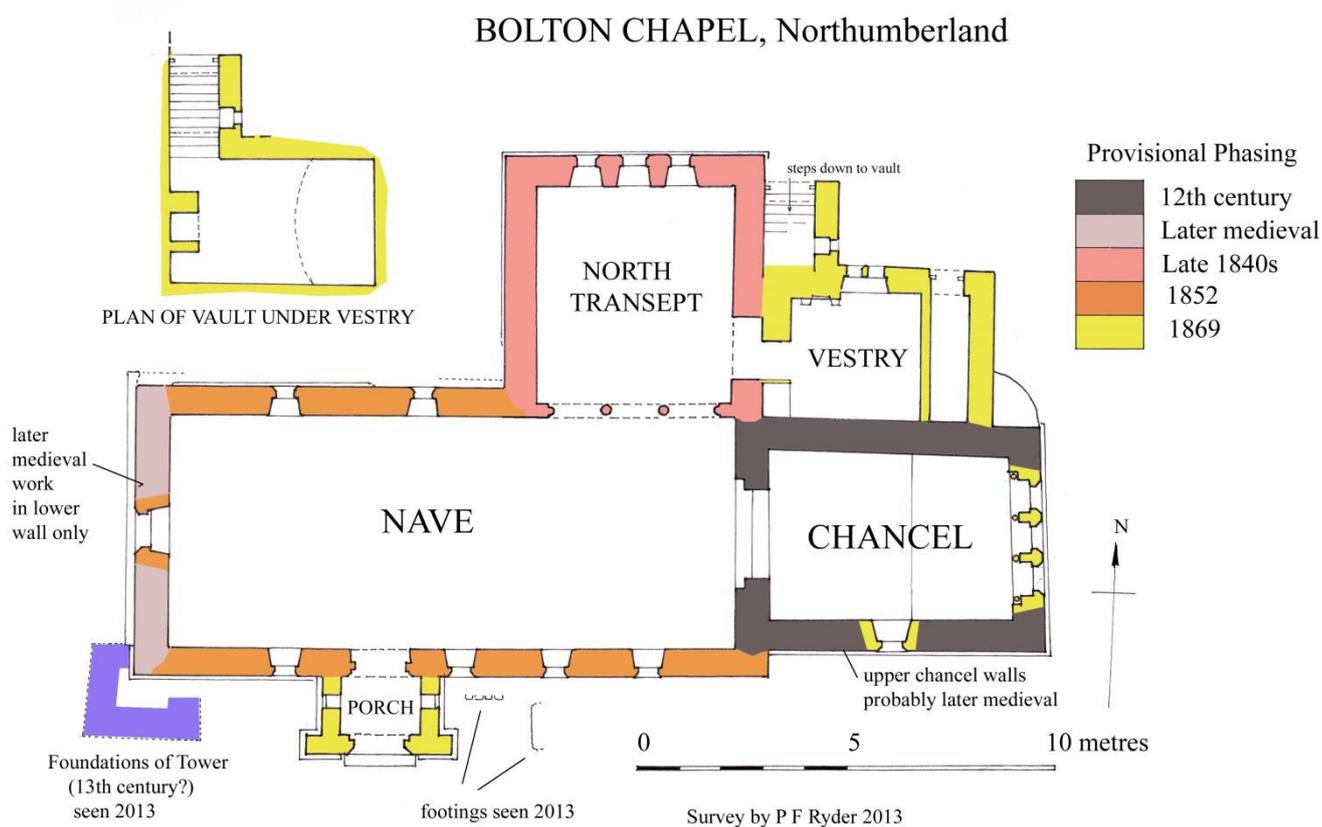
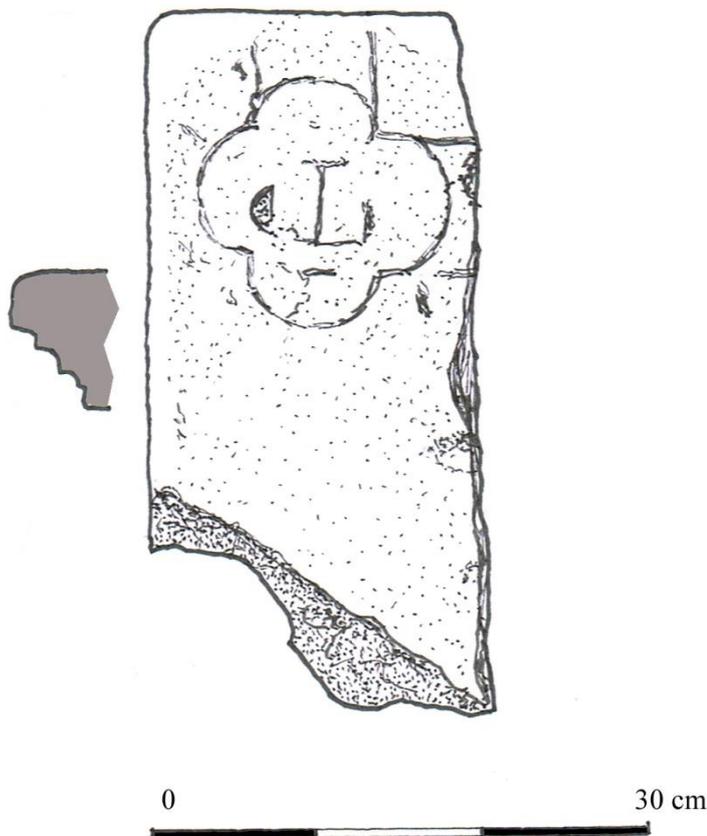
Carved Stone from Bolton Chapel, June 2013

This stone was found re-used in the walls of a small boiler room set in the angle between the nave and north transept of the chapel. It is a slab of buff sandstone, overall 420 by 220mm and c 90mm thick. Its two worked edges, here taken as the top and l. side, are set at approximately right angles, and are slightly rounded; the other two sides are fractures. The incised design consists of a quatrefoil, perhaps set at the centre of a straight-armed cross, although only the r. and upper arms are shown; in the centre of the quatrefoil is an incised motif rather like a capital 'L', with other sinkings below and to the l.

The stone is probably a small grave slab, possibly unfinished, although it is difficult to find any real parallels. Taken on its own, the design looks like one corner of a larger slab that had a border (perhaps with an inscription and a quatrefoil panel at the corner, but it is difficult to relate such a scheme to the shape of the stone, with the 'lower' half of its face devoid of any carving; just possibly it might be a small portion of a much larger monument. It is difficult to suggest a date, other than to say that quatrefoils were a popular motif, ie in window tracery, in the late 13th and 14th centuries.
