THE PARISH CHURCH OF SS PHILIP AND JAMES

AN ARCHAEOLOGICAL ASSESSMENT

JULY 2020

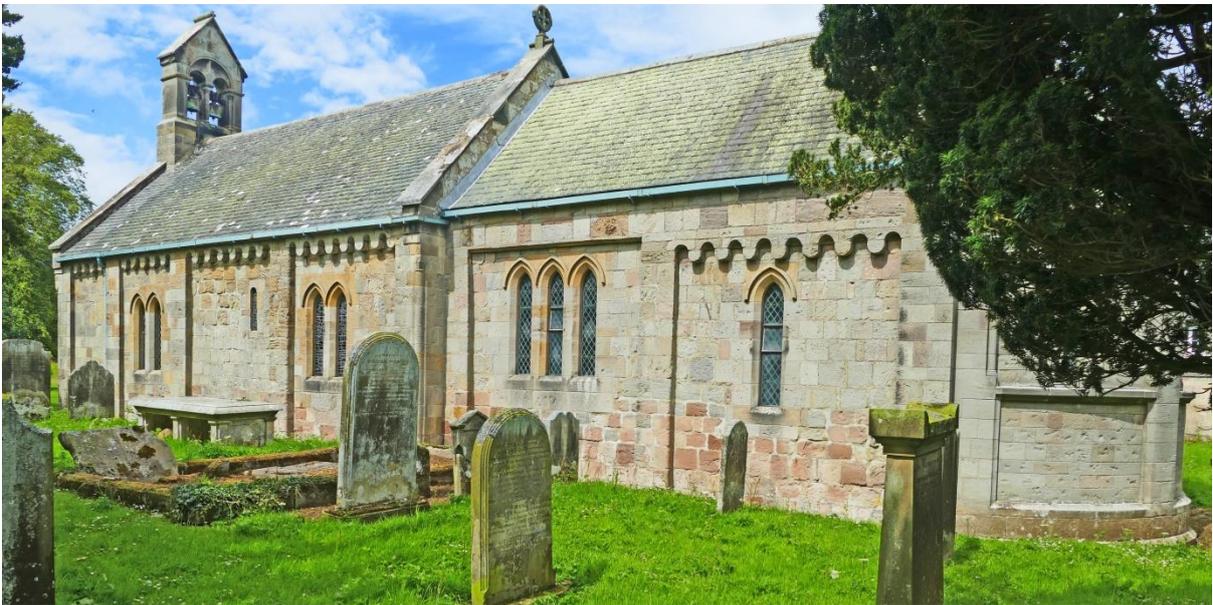
The church from the south east

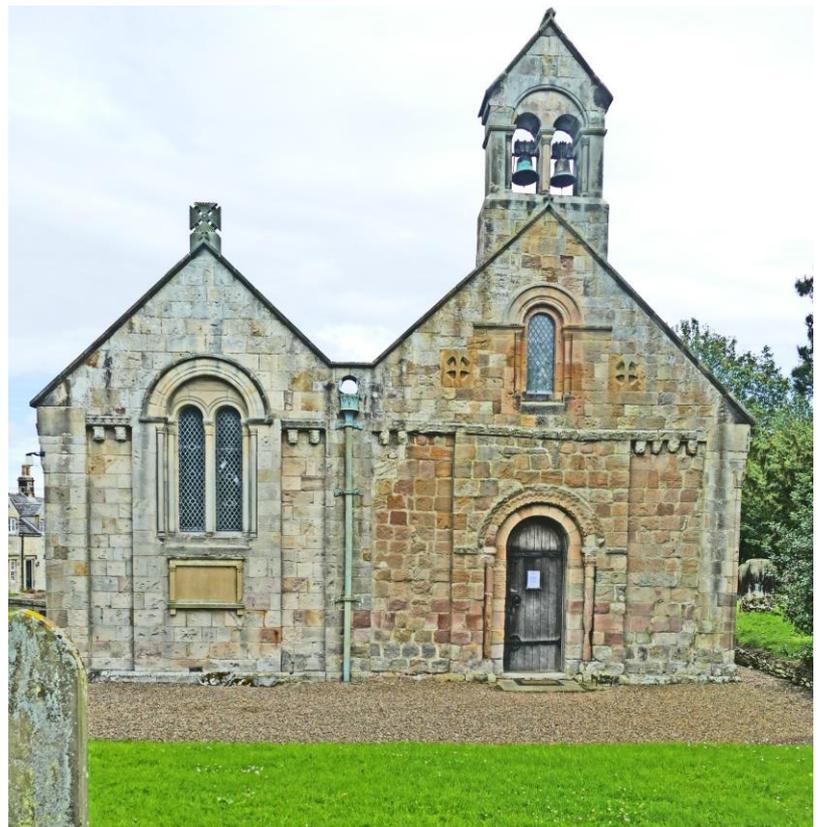
The west end of the **Nave** (right) has a central raised panel containing an original round-arched doorway; its continuous inner order is of plain square section whilst; the outer order of chevron is carried on jamb shafts with worn scalloped capitals, and there is an impost band with tegulated ornament which is carried up over the arch as a hoodmould. Above is a horizontal string course with lozenge

ornament, chamfered above and below and now very worn; the corbel table on either side of the central panel it is carried on four masks, now weathered beyond recognition although a very Victorian take on what they may have looked like is provided by the adjacent gable end of the aisle. The upper gable of the nave is a 19th century rebuild, and has a Romanesque window with a moulded arch on jamb shafts, flanked by sunk cross paté panels, and carries an ornate bellcote in the same style, which has twin round-arched openings with similar detail to the window below. The pilasters at the outer angles of both nave and north aisle have angle shafts with cushion capitals.

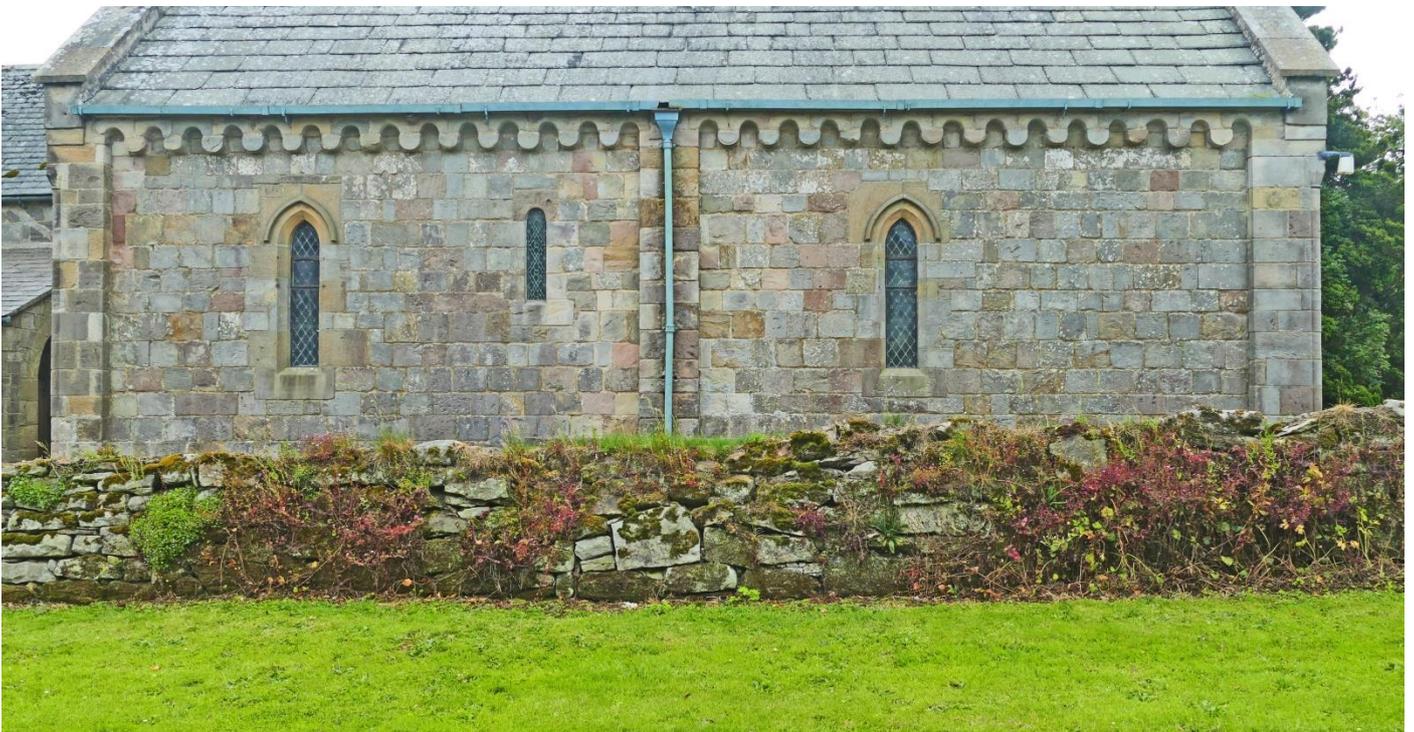
North side of north aisle, originally north wall of nave rebuilt in new position in 1866

arch and big circular light in the head, with a toothed surround, very characteristic of the work of the architect, F.R. Wilson of Alnwick. The north elevation is much more sober, as Wilson appears to have replicated the old north wall of the nave, removed when the aisle was added 'I must record that every sound stone in the ancient wall... was marked and re-used in the new one; the Norman windows in the north wall, especially, are identical'¹. The wall has two broad bays, each with fourteen arches of corbel table. The east bay has a 19th-century lancet set east-of-centre and the west bay a 12th-century round-headed loop, without a chamfer, its sill restored. To the west of the central pilaster buttress is what appears to be a small blocked opening; this probably relates to the pipe that linked the former gas house (on the north side of the village street) to the organ in the north aisle (see notes on organ).

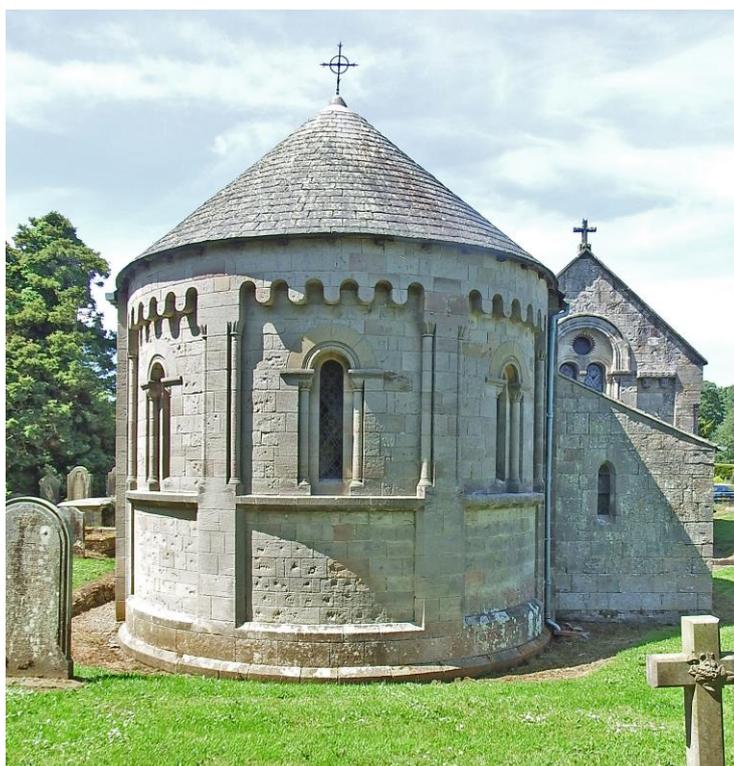
The **Apse** is entirely of 19th-century ashlar, the blocks deliberately pock-marked to give an impression of antiquity. Its three-bay curved elevation broadly follows that of the original parts further west, with plinth, pilasters and arched corbel table, but there is also a bold string course, hollow-chamfered beneath, below a single round-arched Romanesque light in each bay, which have moulded heads, grooved impostes and jamb shafts with scalloped capitals and moulded bases.

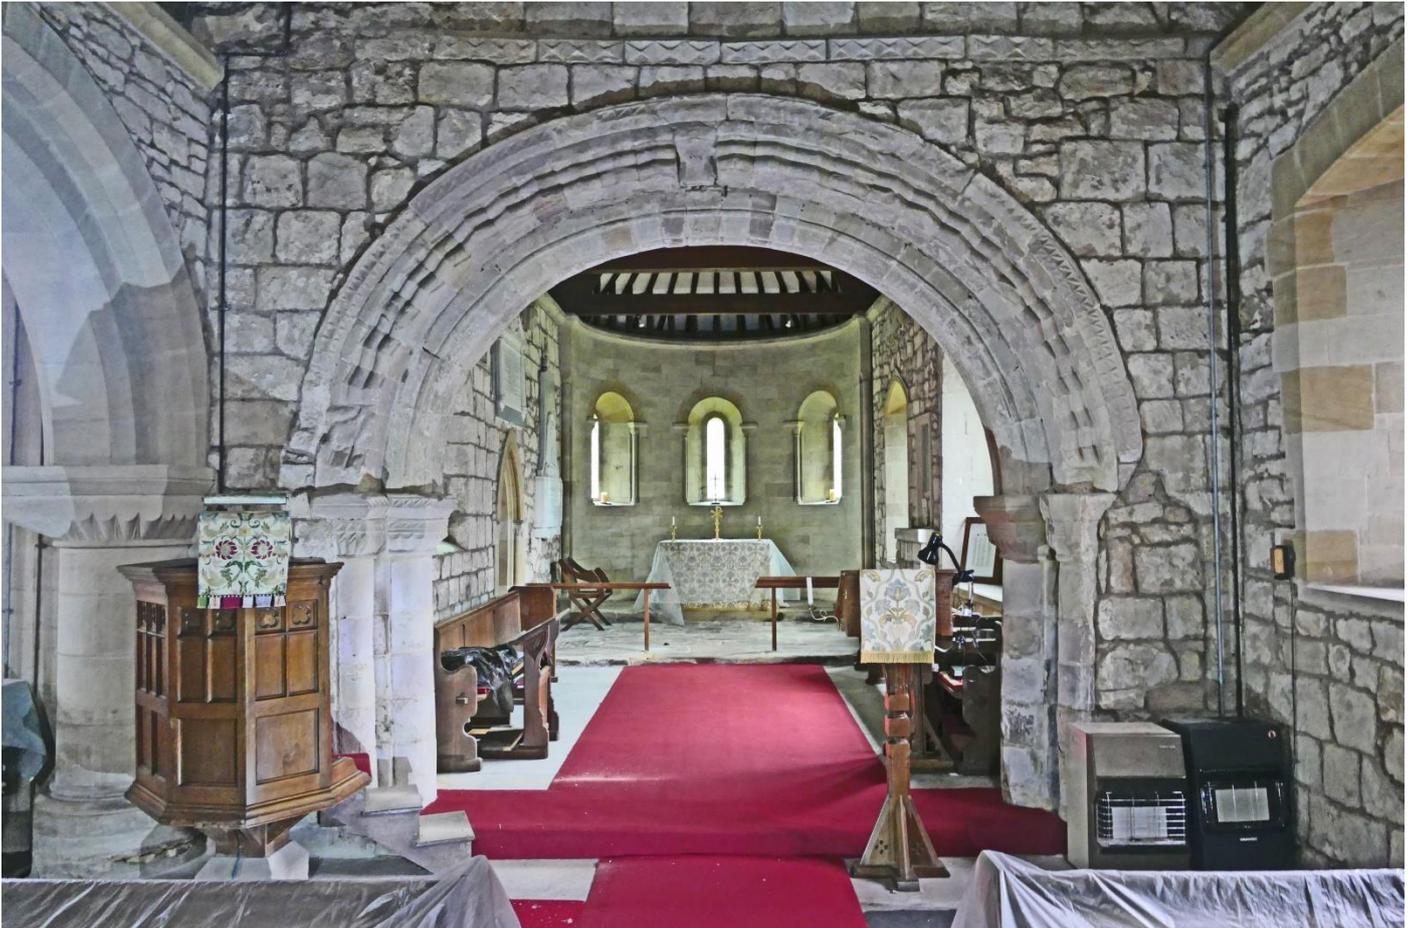
The semicircular arch into the **Chancel** (above) is probably the best original feature of the church. It is of two orders, the inner having a pair of rolls with a fillet between and the outer having bold chevrom to the nave, but is left square to the chancel. Towards the nave there is a hoodmould with a relief zig-zag pattern. A course above the top of the arch is a string with lozenge ornament, forming a slight set back.

The jambs have half shafts carrying the inner order, and, towards the nave, the outer as well. The southern capital has scalloping with three horizontal grooves above, and an impost grooved and chamfered below; the northern (which has more the look of having been re-cut) is rather different, with varieties of zig zag both directly above the scalloping and to the vertical face of the impost as well.(towards the nave). There are no real bases.

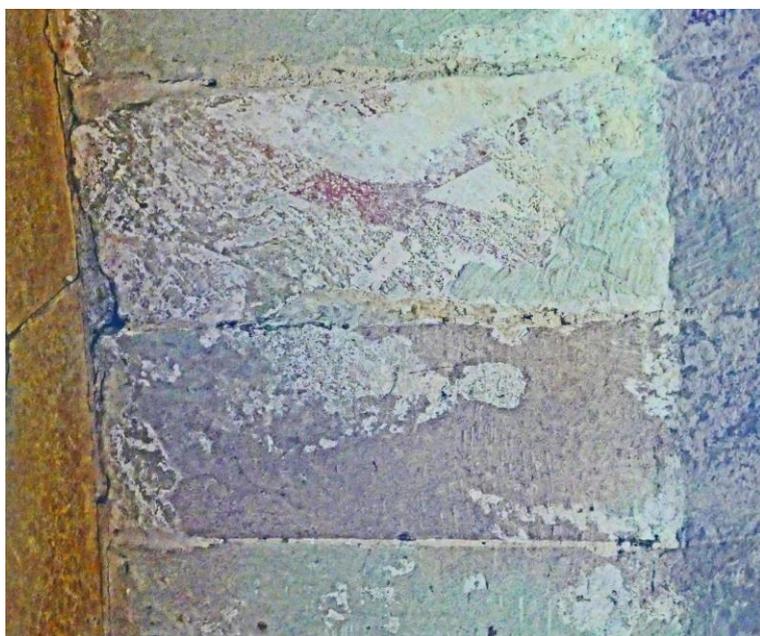
The south wall of the chancel is quite complex. About 0.20 m from its west end and 3 m up there is an infilled socket c 0.25 m square, with below it a ragged vertical joint before the 19th century masonry of the western splay of the three-light window. Above the internal jamb of this window there is what looks to be a blocked opening c 0.90 m high and 0.50 m wide immediately below the 19th century oversailing ashlar course which tops the wall. Returning to the three-light window, its sill is 19th century work (with 12th century fabric below) but parts of the eastern splay are older, as is the broad segmental rear arch, which has a broad chamfer and an internal label with a round stop to the east and an acute turned-back end to the west. The soffit of its rear arch retains old plaster, with remains of medieval wall painting (below) .

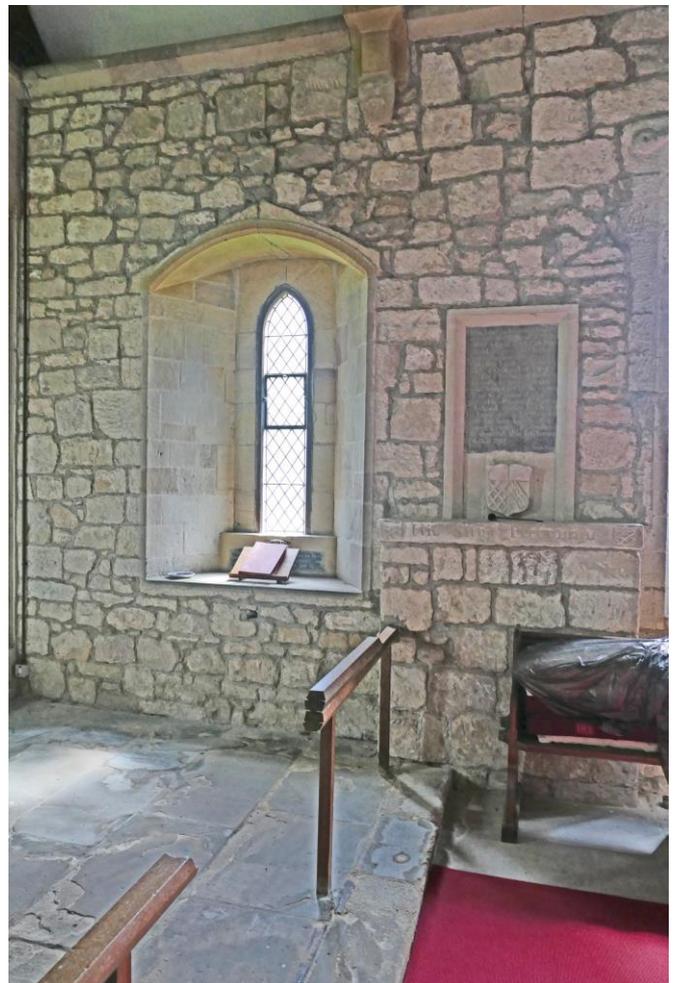
Chancel looking south-east; note indications of removed cross-wall (top right) and coursed rubble exposed by ? thinning of wall.

Perhaps the best explanation is that the chancel was only one bay long, with a sanctuary beyond (although there was no external division between the two parts); there are indication of a cross wall which could have contained a second large arch (cf Bolam, Seaton Delaval, and perhaps Thockrington) . The sanctuary may well have had thicker walls (as at Seaton Delaval, perhaps because it was vaulted. At some later date this vault may have been removed and the inner faces of the walls cut back, leaving rubble core as at present. The north-eastern window was inserted after this was done.

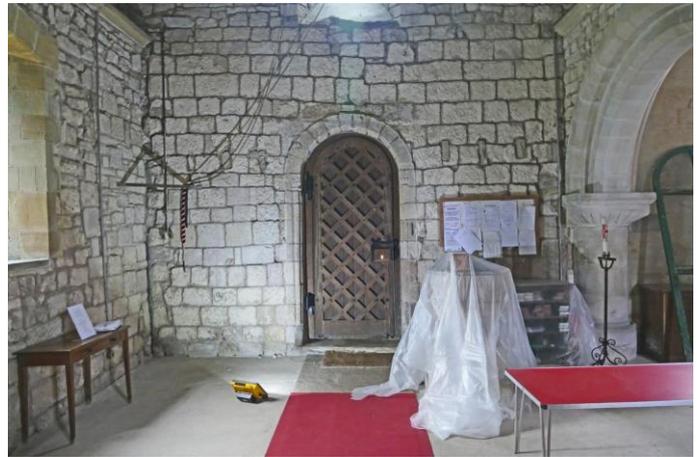
West wall of nave, with sockets for gallery timbers

The west wall of the **Nave** is largely of typical squared 12th century stone, with a ragged vertical break very close to the south end – the western bay of the south wall has been rebuilt, and this may indicate the line of its original inner face. Close to the north end and c 2 m above the floor is a larger ragged infilled socket. The west door has a semicircular rear arch, of plain square section, set on jambs with attached shaft that have fluted capitals, perhaps re-cut. The arch cuts across a horizontal series of upright sockets, clearly for the floor of a western gallery; there are indications that one joist was set against a voussoir of the rear arch, suggesting that the doorway (which might conceivably have been re-set from elsewhere) pre-dates the gallery, so the best explanation to get round this awkward relationship of rear arch and gallery is that the doorway was blocked when the gallery was created. Higher up there are some discrepancies in the coursing – the northern part of the wall has rather more elongate blocks, and may have been rebuilt, and in the gable, where the window has a plain round-headed rear arch, smaller and more roughly-coursed stone is used.
