St John the Baptist
Edlingham
Northumberland
An Archaeological Assessment
March 2016

PETER F RYDER
B.A., M.Phil, F.S.A
HISTORIC BUILDINGS CONSULTANT

St John the Baptist, Edlingham

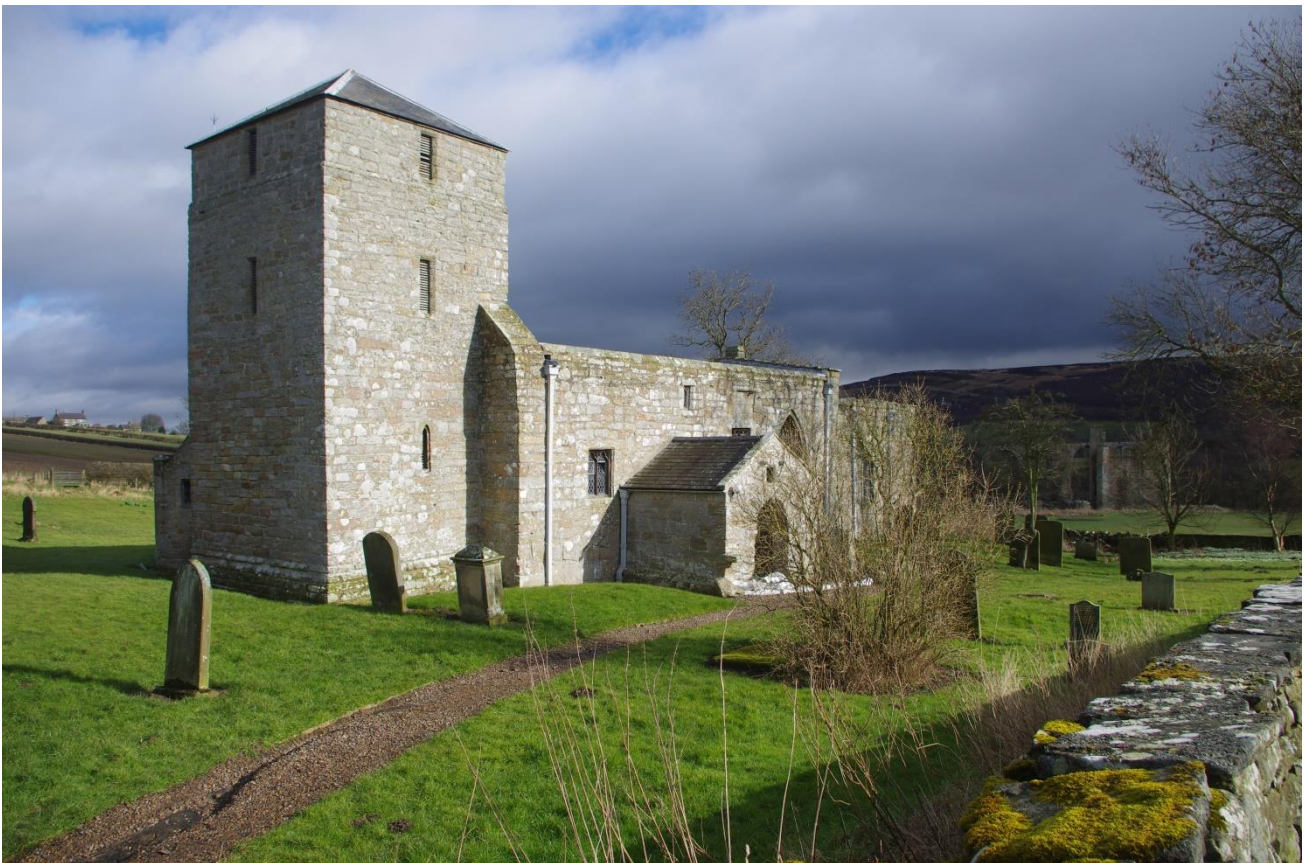
The church from the south-west.

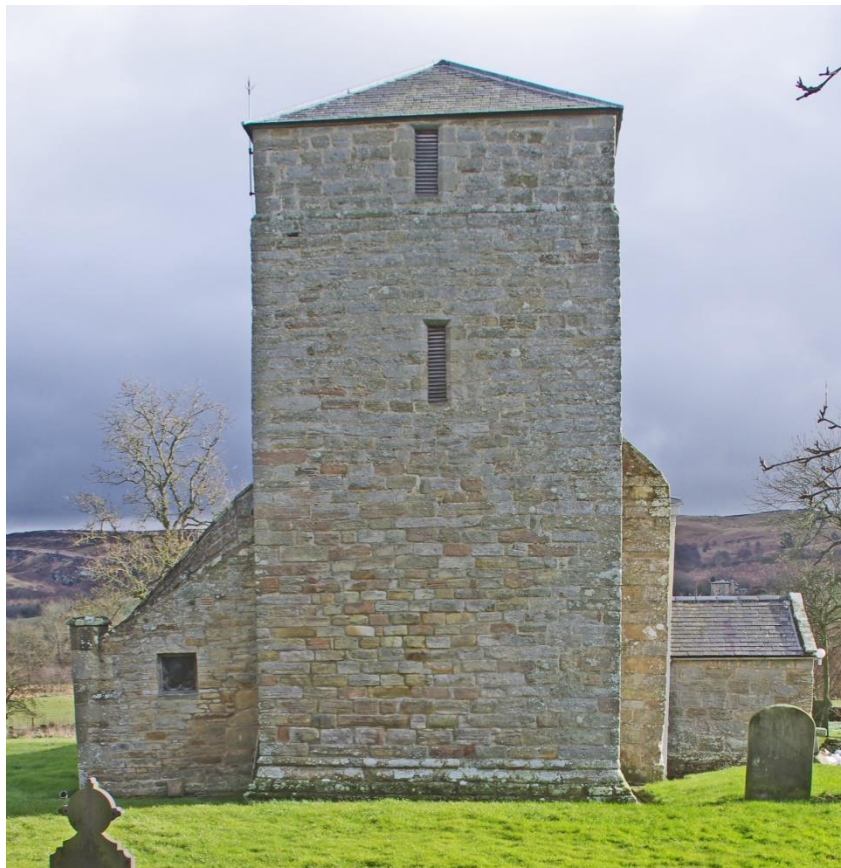
The **West Tower** is constructed of coursed squared sandstone in various shades of grey, pink and yellow; at the foot of the wall is a bold plinth, consisting of here stepped-and-chamfered courses, with a string-course, chamfered above and below, directly above; on the west the southernmost block of the course above the plinth bears an Ordnance Survey benchmark. The tower is otherwise a severely plain piece of architecture, and rises in two stages, divided only by a simple set-back around a metre below the eaves. The only window of the lower stage is a small and narrow lancet, with an external square rebate, set well above the ground. The first floor has larger square-headed windows, in a simple chamfered surrounds, on south, west

and north. The belfry, above the set-back, has smaller but similar openings in the same three sides – that on the west is set a little to the north of the line of the first-floor window below. On the east an earlier gable, outlined by a raised roof-tabling, is incorporated in the tower, its apex rising a little above the set-back; the only opening is the rear arch of the oculus visible internally (now blocked), and this is quite remarkable, a megalithic block around 1 m square with a circular opening c 0.50 m across cut into it. The tower is topped by a low-pitched pyramidal roof.

The tower from the west

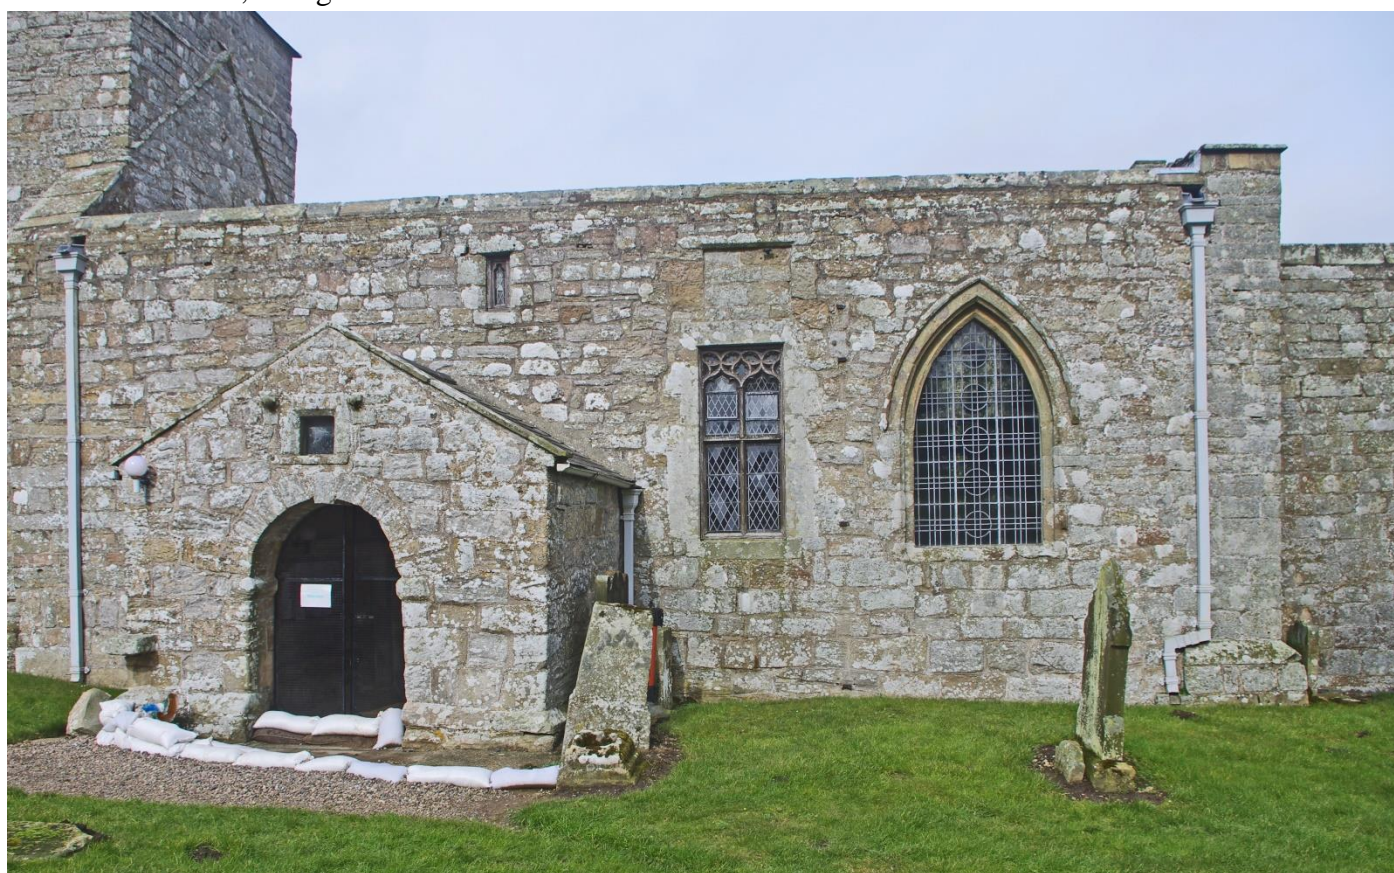
The **Nave** is built of coursed roughly squared stone. At the base of the south-west quoin are two megalithic blocks, but the quoins above are shallower, although some are up to 2 m long, and might be re-used grave slabs; this section of walling is of very similar fabric to the tower, and may be of the same build. A couple of courses of large blocks run the length of the south wall of the nave, stopping short of the south-eastern quoins which are mostly normal walling stones, but at their base is a broad chamfered plinth, which abruptly ends to the west; has it been cut away? The plinth returns to the north along the east wall of the nave, and appears to be overbuilt by the south wall of the chancel. The wall is topped by a simple chamfered coping. The south porch projects from the south wall, west-of-centre; west of the porch is square-headed chamfered opening, now containing a c1900 timber window of two trefoil-headed lights. Above and a little to the east of the ridge of the porch is a small rectangular light, with chamfered jambs but a plain square lintel (with a socket for a central bar), now holding a small timber trefoil-headed light. East of the porch is a tall rectangular window with horizontally-tooled dressings of 18th-century character, again holding a c1900 timber window; directly above it is a blocked square-headed opening with a chamfered lintel and jambs that look to have been roughly hacked back. Near the east end of the wall is a large window with a two-centred arch, of two orders, the inner chamfered and the outer with a concave chamfer, under a slender casement-moulded hood; this all appears medieval, and it probably once contained tracery; it now holds 20th-century leaded glazing. At the north-west corner of the nave some substantial quoins are visible above the vestry roof; at the north-east corner two or three megalithic quoins survive low down, above which the wall seems to have been refaced; just within the lowermost quoin is a squared block c 0.40 m square projecting c 0.15 m from the wall face, its significance now obscure.

The Nave from the south

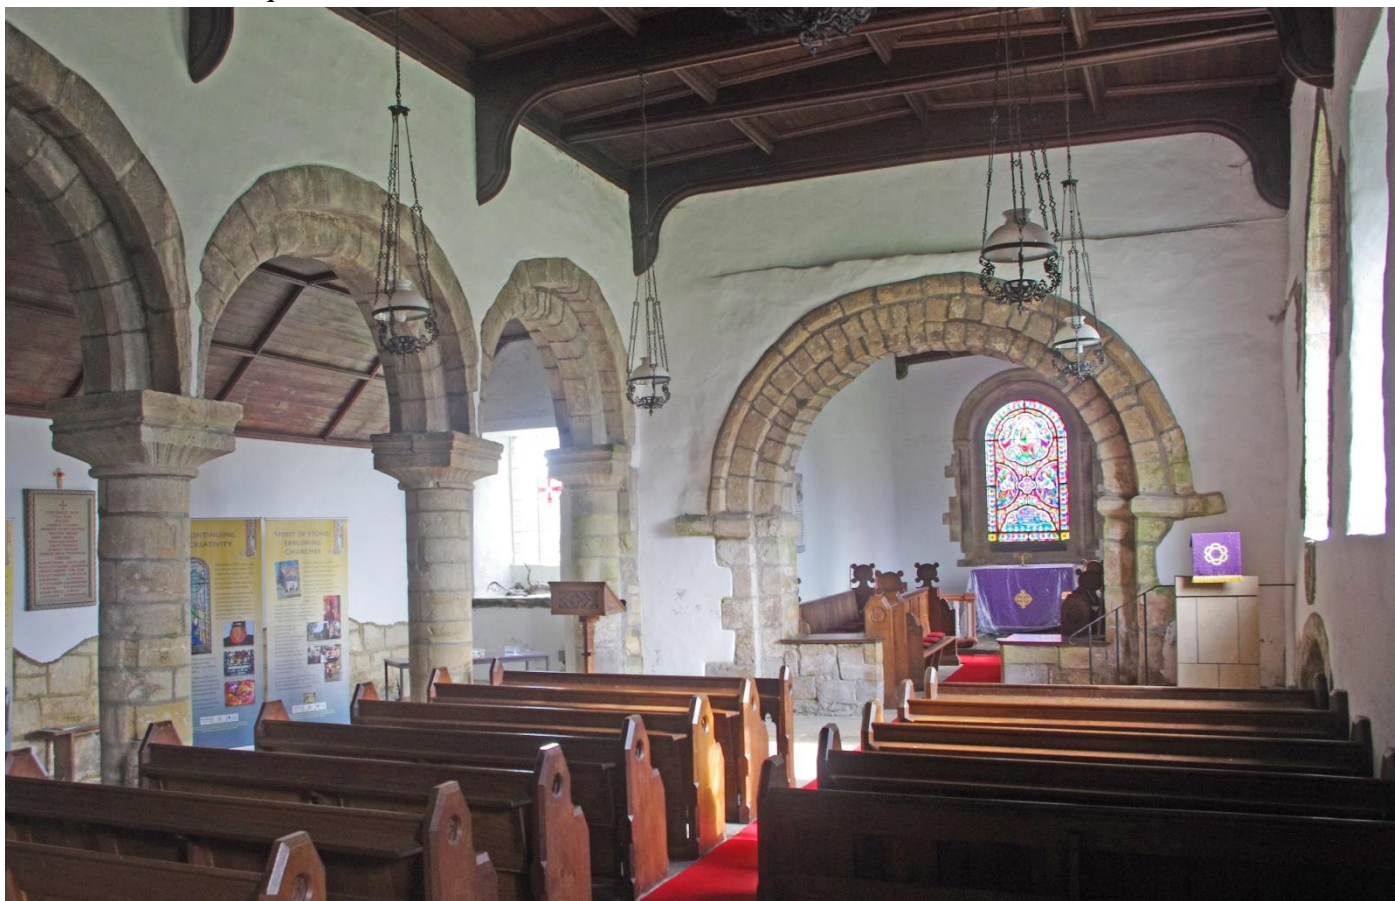
On the north of the nave is a four-bay arcade with circular piers, semicircular responds and round arches, with detail consistent throughout its length. The piers and responds have squared chamfered plinths and 'holdwater' bases with a line of nailhead ornament; the piers have capitals with vertical lines of nailhead simulating scalloping, and grooved and moulded abaci; the arches are of two orders, the inner with a narrow chamfer, the outer square. There is no hoodmould.

The Nave looking north-east

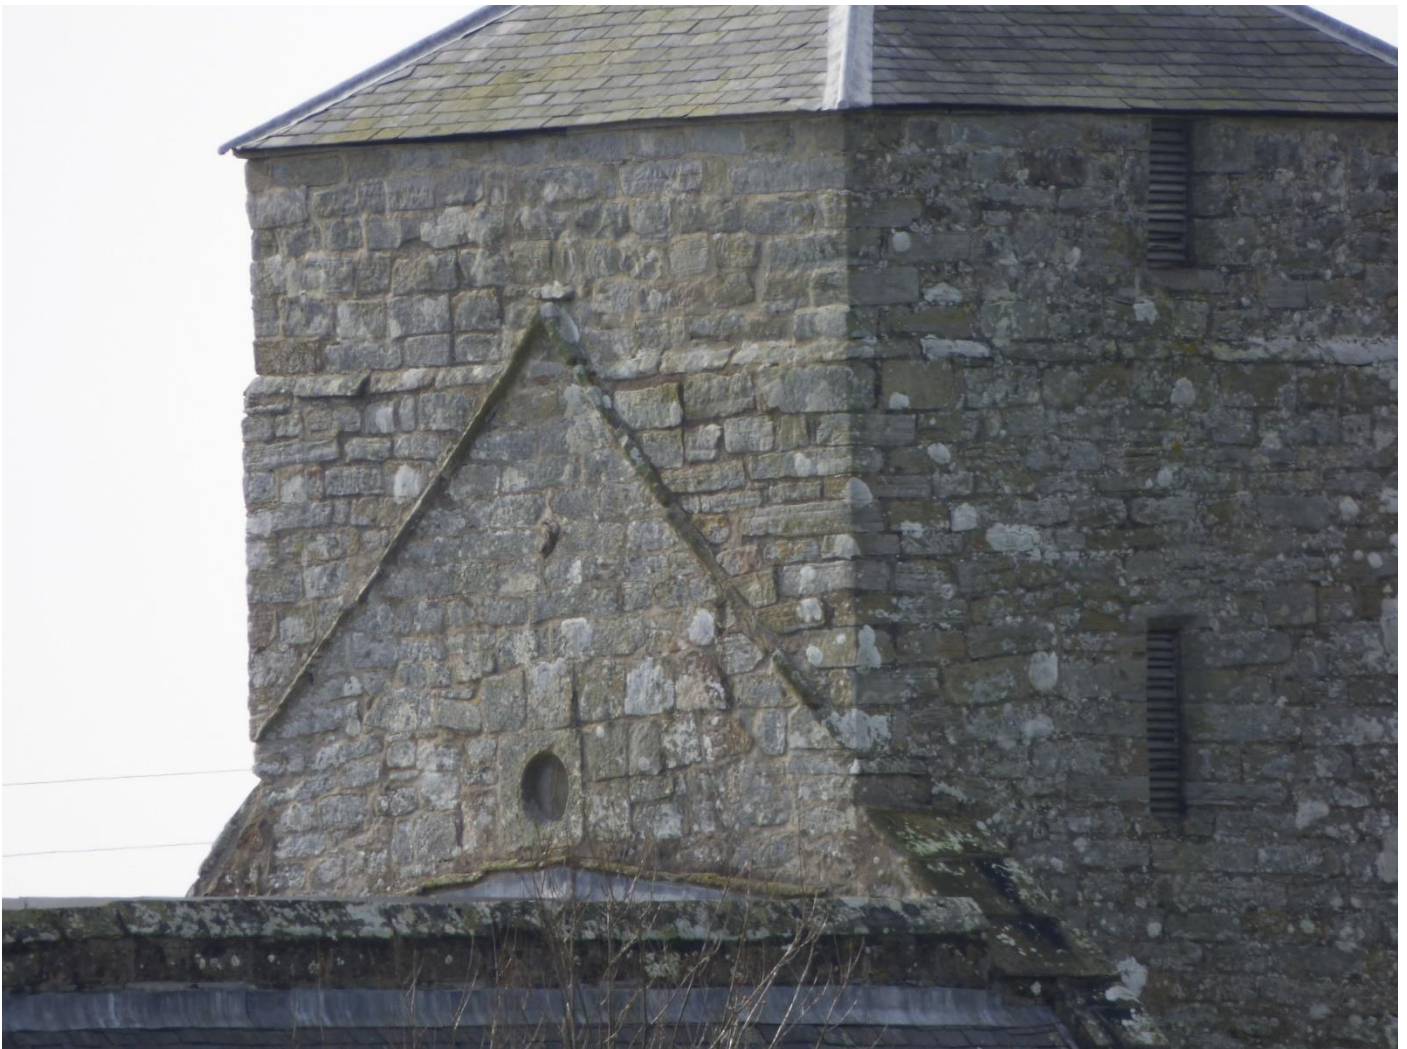
The east side of the tower, showing the roof tabling of the early gable and the internal face of the oculus

The only detailed plans and drawings of the church available date from c1900, and although reasonable for their time are not up to modern standards. In view of the importance of the early fabric in the west wall, it is desirable that good-quality elevation drawings, or rectified photographs, are prepared of the internal elevations of the tower, and west end of the nave, including the tower wall above the nave roof, which merits close examination but can only be accessed from the roof.

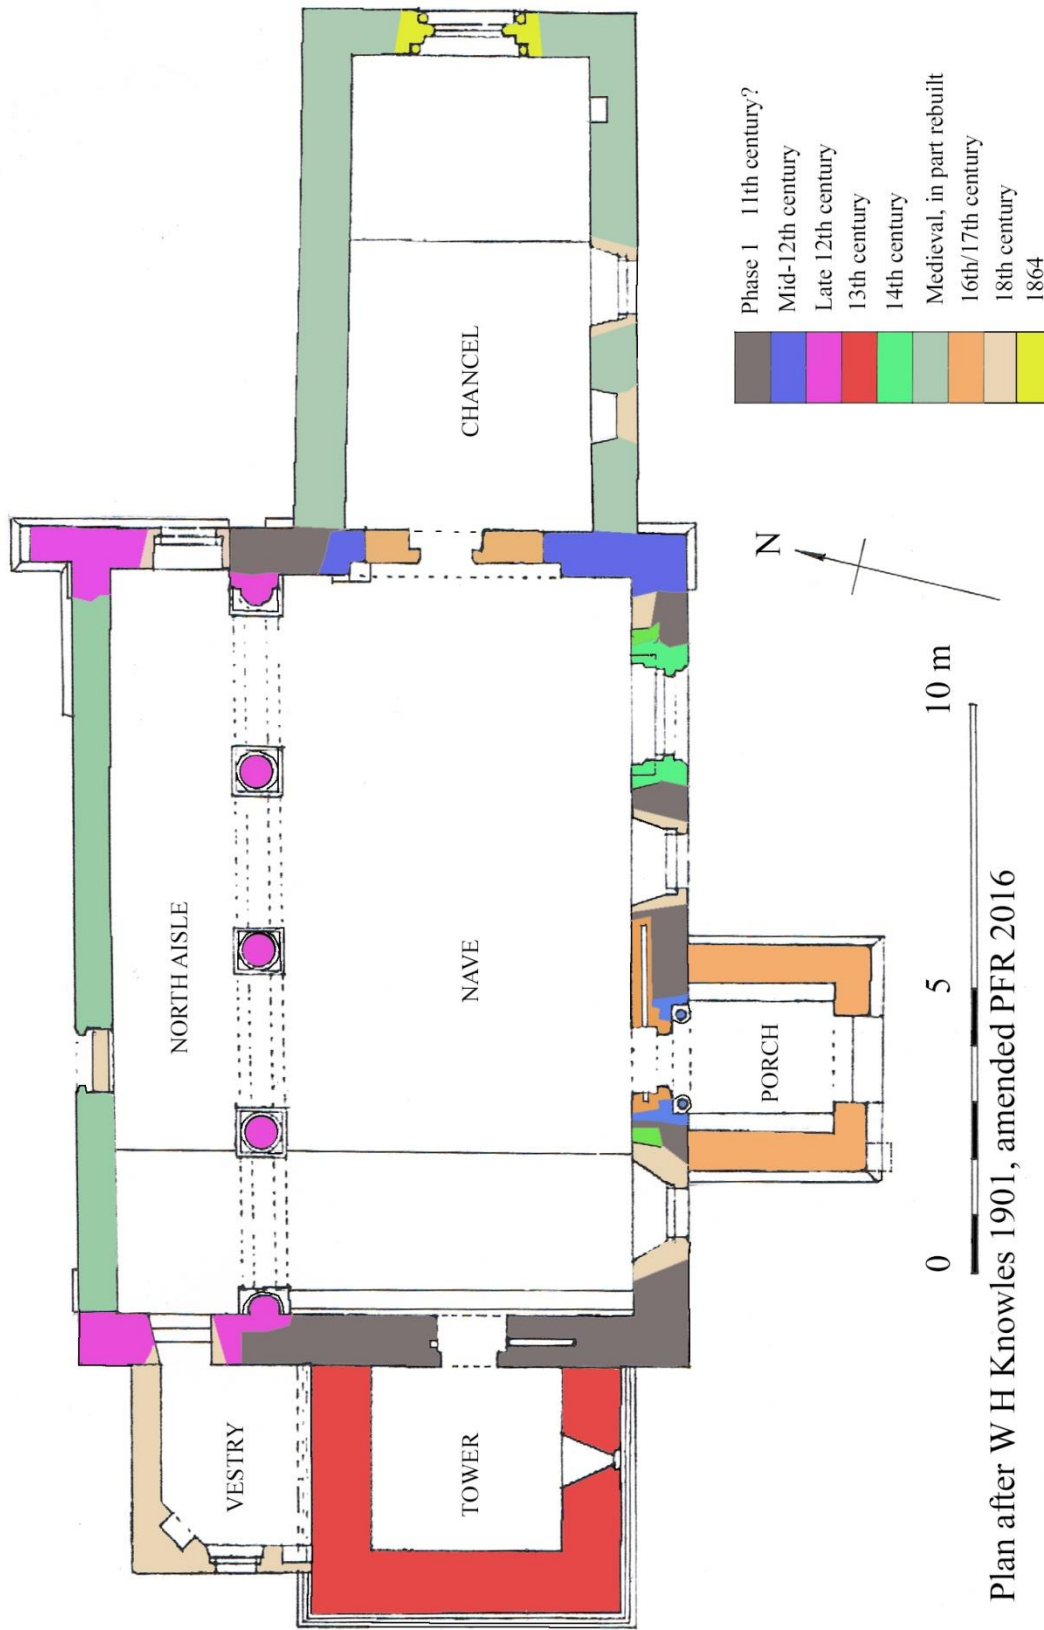
Plan after W H Knowles 1901, amended PFR 2016
