THE PARISH CHURCH OF ST MARY, MORPETH  
ARCHAEOLOGICAL WATCHING BRIEF  
WINTER 2012/2013

**St Mary's Church, Morpeth. Archaeological Watching Brief, Winter 2012/2013**

**NC ref. CM 16/19; 15569. NGR NZ 1971 8509. PFR 877. Oasis ref. peterfry1-144515**

### **An Archaeological Watching Brief, Winter 2012/2013**

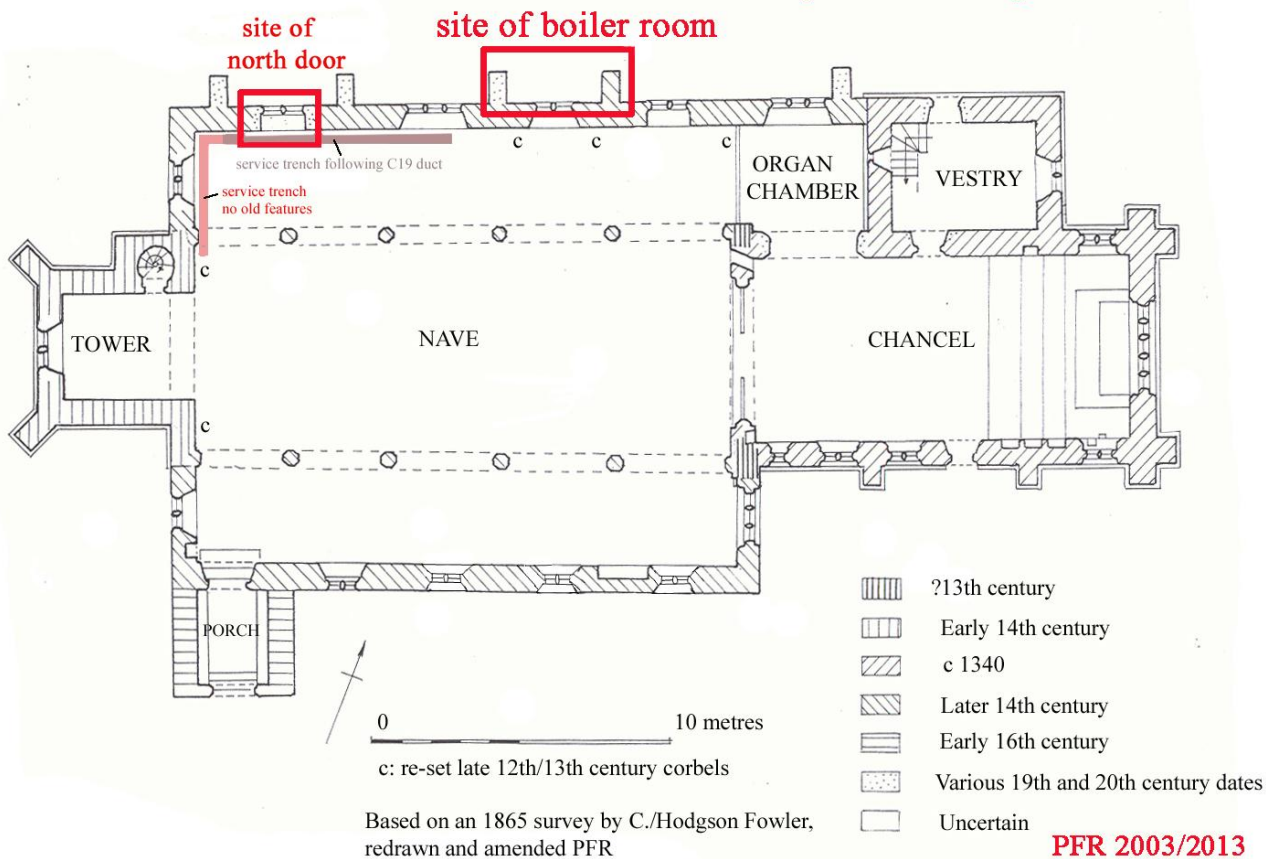
Illus.1. Phased Plan showing locations of archaeological recording

**ST MARY'S CHURCH, MORPETH**  
**Provisional Phased Plan** **showing locations of**  
**archaeological recording, winter 2012/3**
